This Service Information bulletin supersedes S.I. 65 30 06 **dated October 2006.**

SIRIUS Satellite Radio is Inoperative

E83 (X3) with SDARS

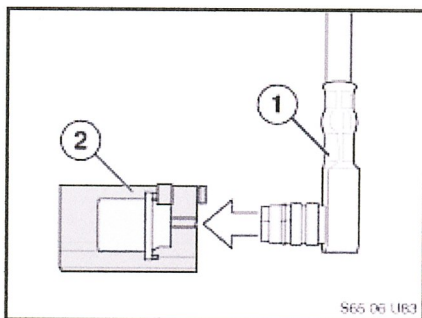
The SDARS antenna in the shark fin and the connector on the SDARS coax cable coming from the receiver is incorrect.

There are two connectors on the SDARS antenna instead of only one and the color coding of the connector on the coax cable is incorrect.

1. Remove the rear roof trim to get enough space to access the connectors on the SDARS antenna, refer to RA 51 44 013 (Removing and installing roofliner).
