SUNROOF DIAGNOSIS WHAT IS THE ISSUE?

WATER LEAKS

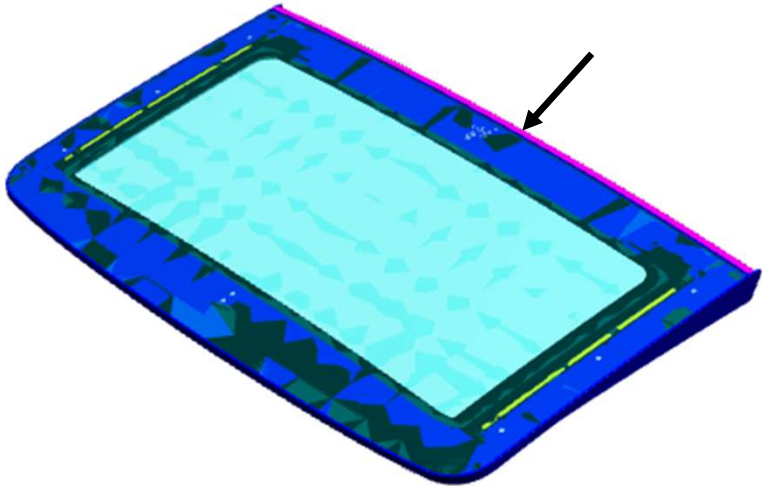
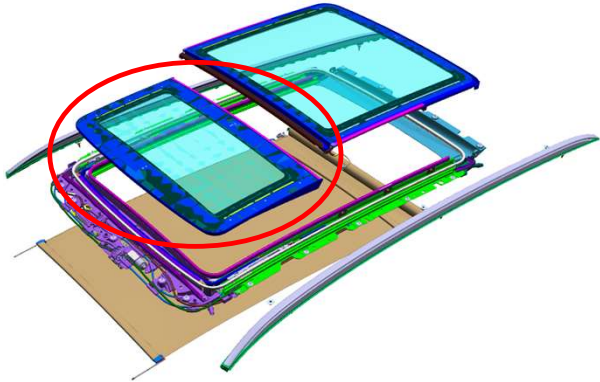
FRONT CENTER SEAL LOOSE/SHRINKING

Defect: separated

Defect: shrunken / gap

Situation: Excessive water enters through the sunroof seals.

Repair: Look for gap near end of the seal on front glass. If found, replace seal according to ISTA/AIR instructions REP 54 13 052. Also refer to B54 04 21.

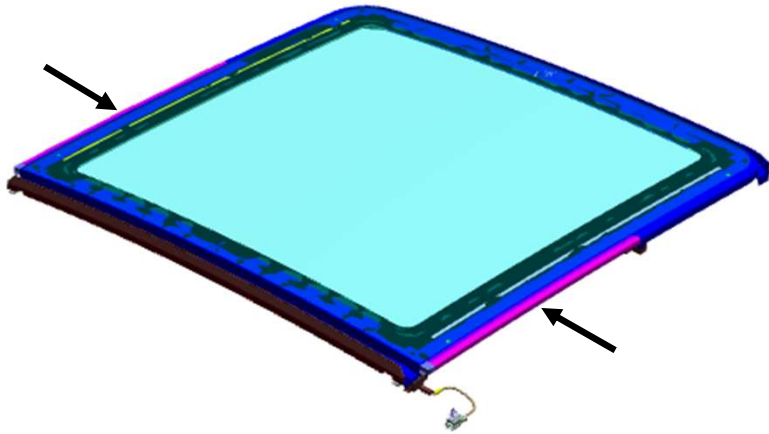
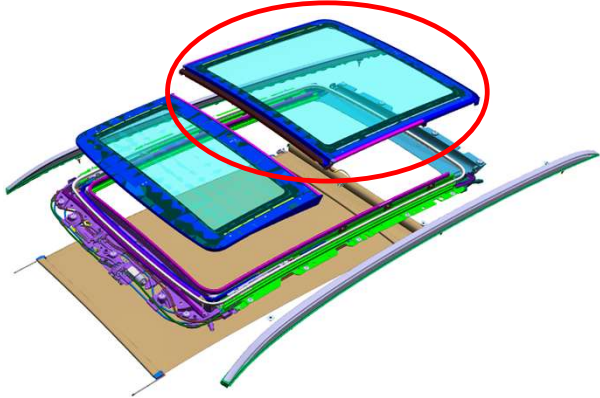
SIDE SEAL LOOSE/SHRINKING

Defect: gap

Defect: twist

Defect: loose

Situation : Excessive water enters through the sunroof seals. (see pictures)

Repair: Look for gap near ends or twist in seal. If found, replace seal according to ISTA/AIR instructions.
REP 54 13 050

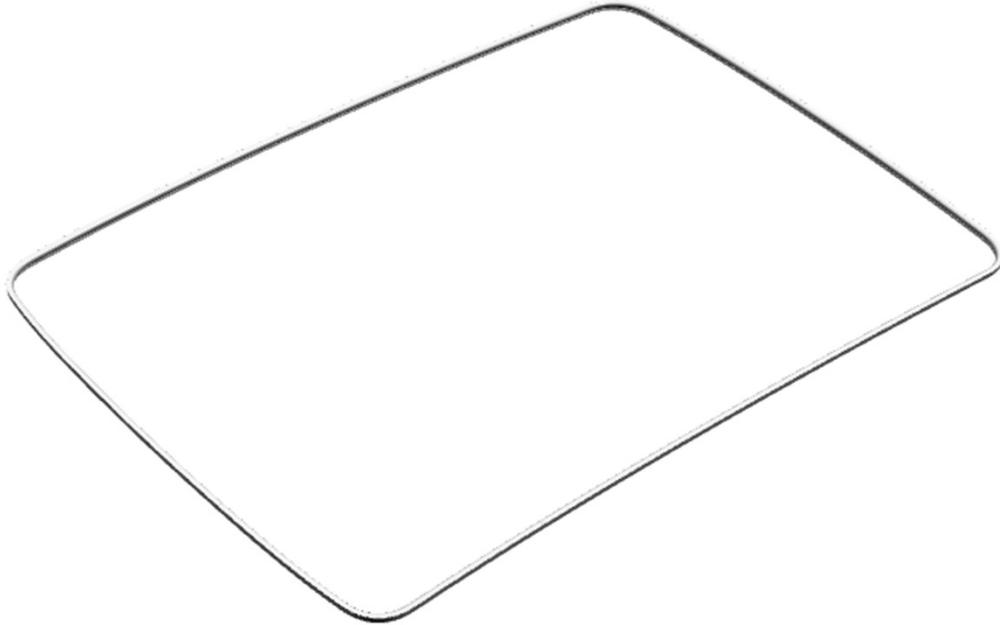
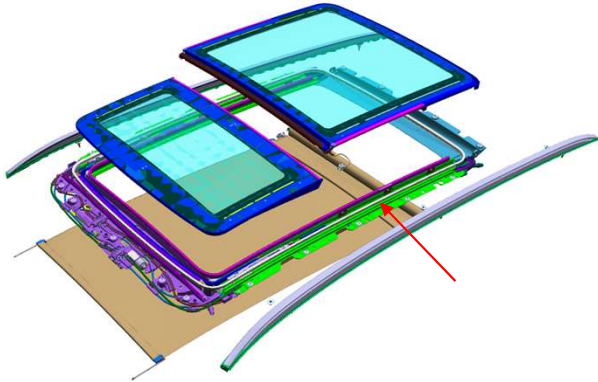
BODY SEAL NOT ATTACHED

Situation : Excessive water enters through the sunroof seals.

example: gap/not flush

Repair: Inspect the sunroof perimeter seal for defects. Replace body seal according to ISTA/AIR instructions REP 54 13 055.

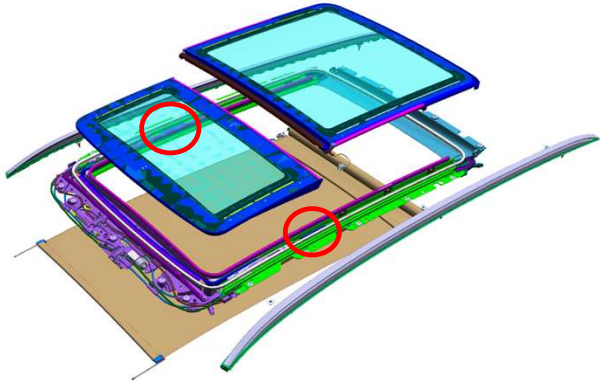
DYKO FOAM/SEAL- WATER INTRUSION INTO DRY SIDE OF CHANNEL

Solution: If there is a water leak near the middle drain channel, check position of the seal and foam.

(!) If NO foam/seal is present, the root cause of a water leak is NOT the foam/seal. Missing foam/seal will NOT CAUSE A WATER LEAK!! DO NOT REPLACE THE FFRAE FOR THIS.

- Possible corrections to foam/ seal;
- Ensure that the outside edge of the foam/ seal is tucked under/ behind the lip of the rear glass drain channel. (See correct position in photos below).
 - Ensure the Z height setting of the rear glass panel is correct so water flows into the outer channel of the cassette.(See correct position in photos below).

Repair: Check position of the seal/ foam. Remove foam/ seal if deformed or damaged.

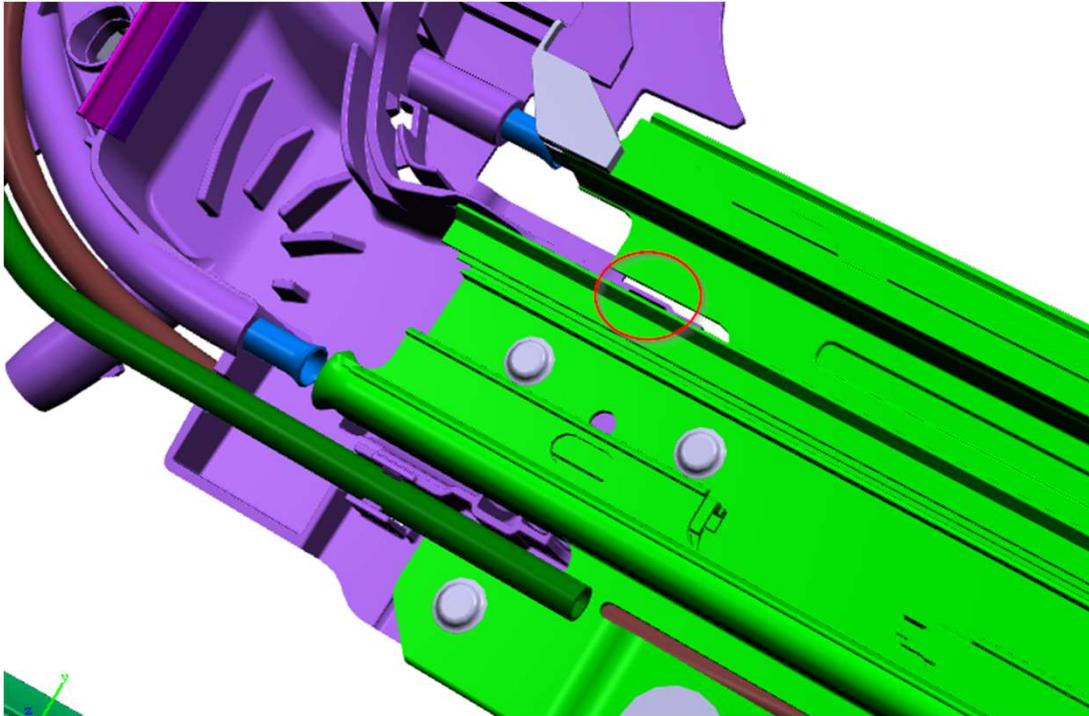
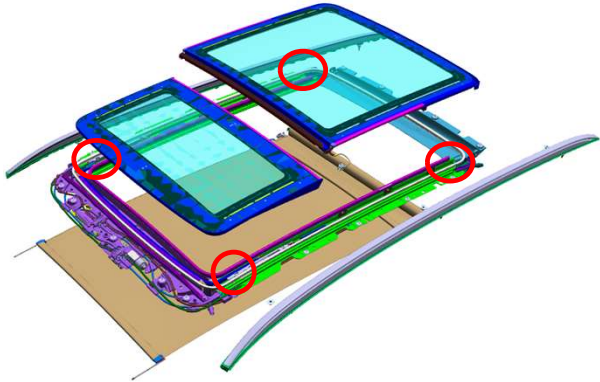
MISSING BUTYL BETWEEN SIDE GUIDES AND BEAM

Situation : There is a water leak running between front/rear beam and side guide.

Repair: There may be missing butyl sealer. ENSURE ALL OTHER WATER MANAGEMENT (SEALS, DRAINS) ARE CHECKED FIRST. ENSURE PROPER WATER TESTING PROCEDURES ARE BEING FOLLOWED (DO NOT OVERFLOW THE SEALED TRACK)
Replace frame according to ISTA/AIR instructions REP 54 13 261.

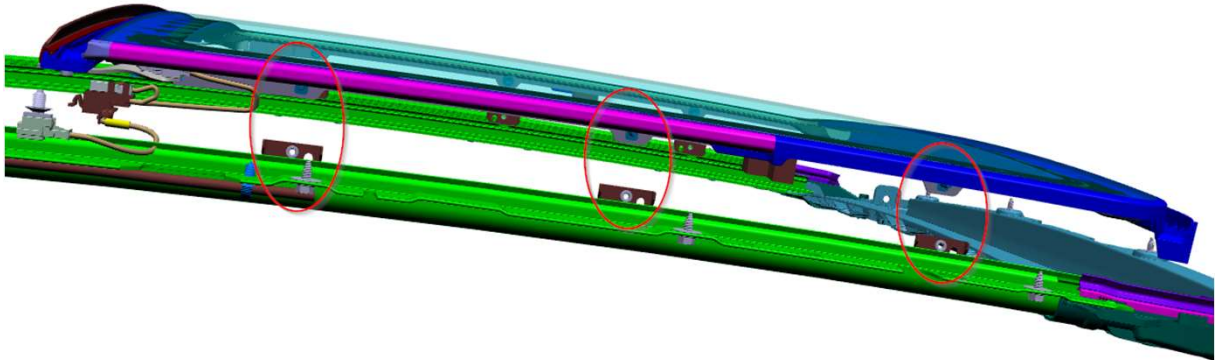
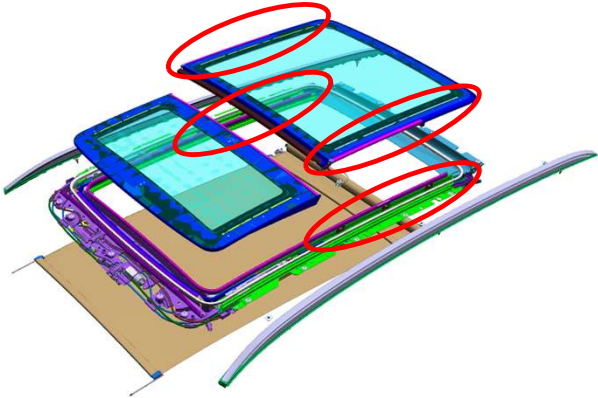
REAR GLASS NOT ALIGNED LEFT TO RIGHT

Situation: Excessive water enters a gap between the side seals and body.

Repair: Check the seals. If seals are OK, check left to right alignment of rear glass (minimal adjustment possible).
Adjust the rear sunroof glass and recheck left to right adjustment. Potential adjustment is very minor. If issue persists then replace frame according to ISTA/AIR instructions REP 54 13 261.

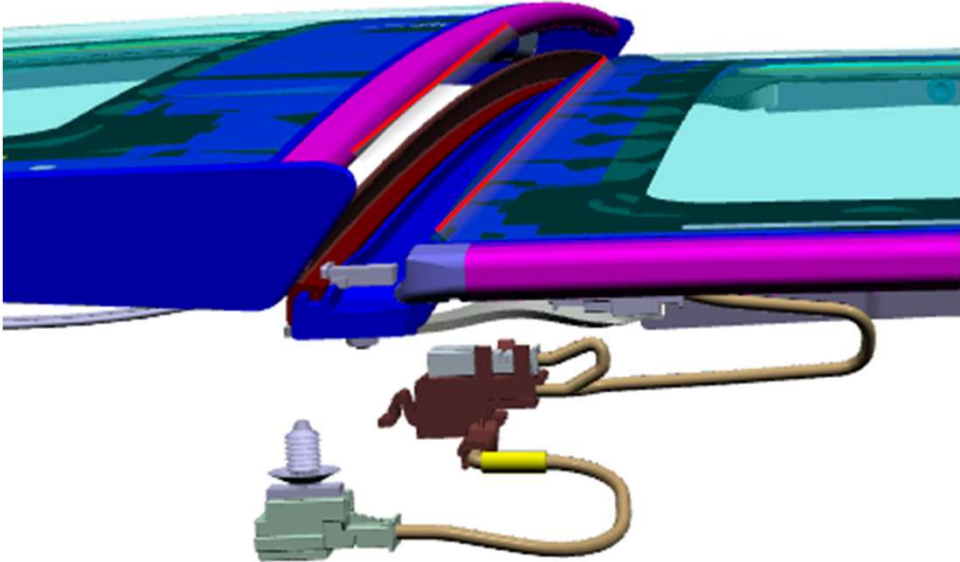
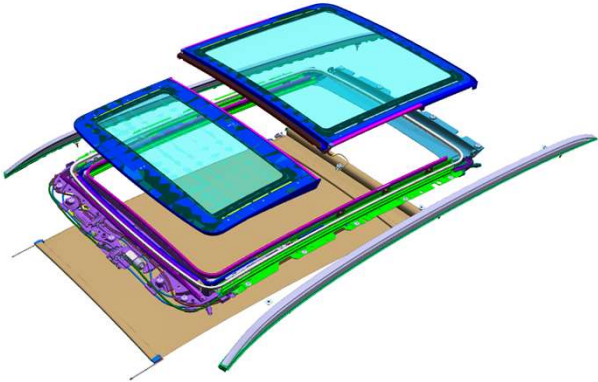
FRONT/REAR GLASS NOT ALIGNED IN X

Situation: Excess water enters the perimeter of the glass. Front and/or rear glass panels misadjusted front to rear.

Repair: Adjust both sunroof glass panels according to ISTA/AIR instructions REP 54 13 002.

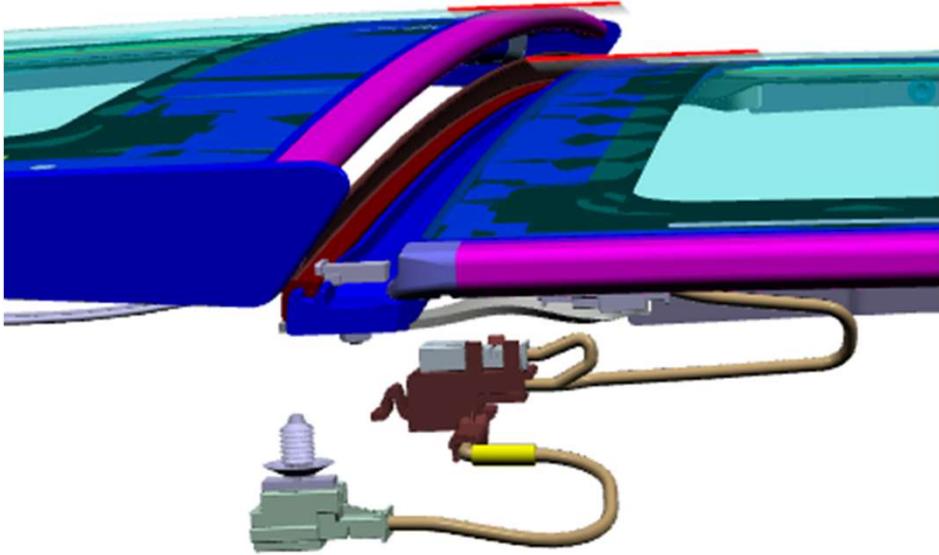
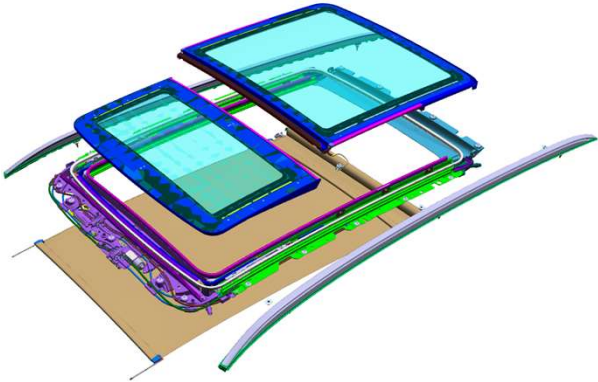
FRONT/REAR GLASS NOT ALIGNED IN Z

Situation: Excess water enters between the glass panels. Front and/or rear glass panel height misadjusted.

Repair: Adjust both sunroof glass panels according to ISTA/AIR instructions REP 54 13 002.

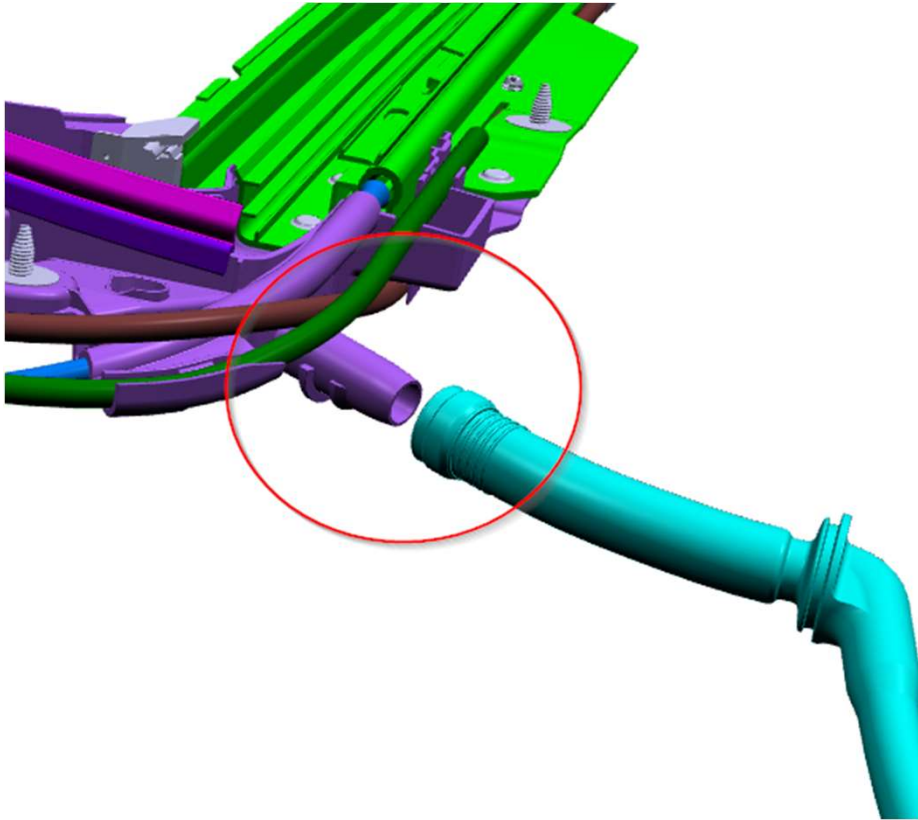
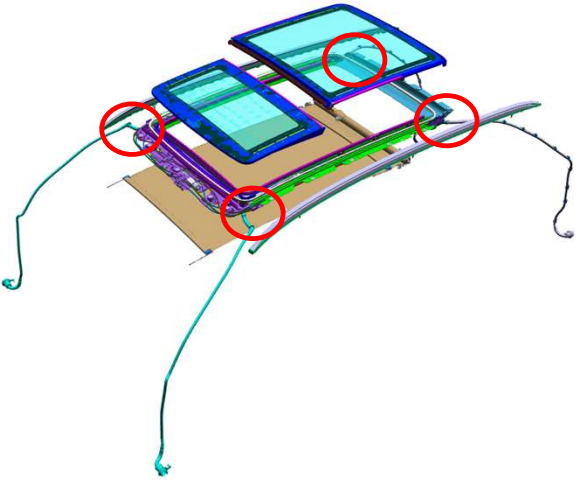
DRAIN TUBE NOT CONNECTED AT TOP

Situation: There is a water leak near the trunk area or you have a water leak near the front carpets. The drain tubes may not be properly connected at the sunroof frame (the top).

Repair: Check the drain tube connections at the sunroof. Reconnect if necessary.

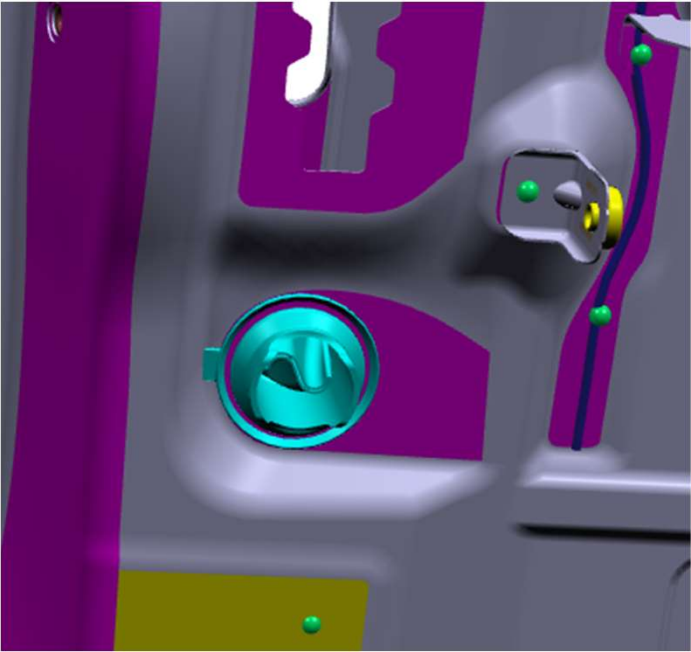
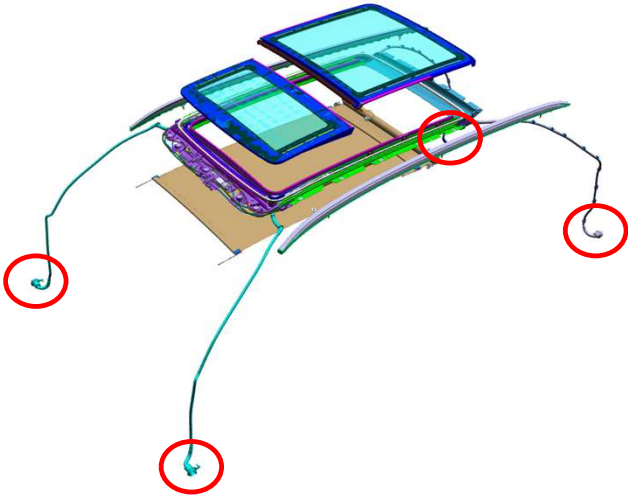
DRAIN TUBES NOT CONNECTED AT BOTTOM

Situation: There is a water leak near the trunk area or you have a water leak near the front carpets. The drain tubes may not be properly connected at the A-Pillar or D pillar at the bottom

Repair: Make sure that drain grommet is seated correctly in the A-Pillar. If not, correctly seat grommet.

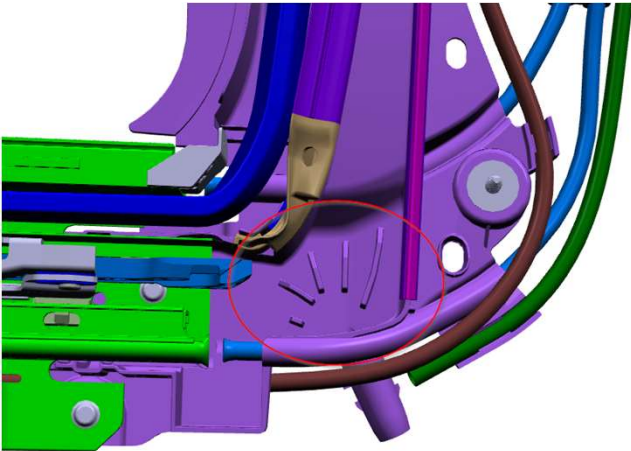
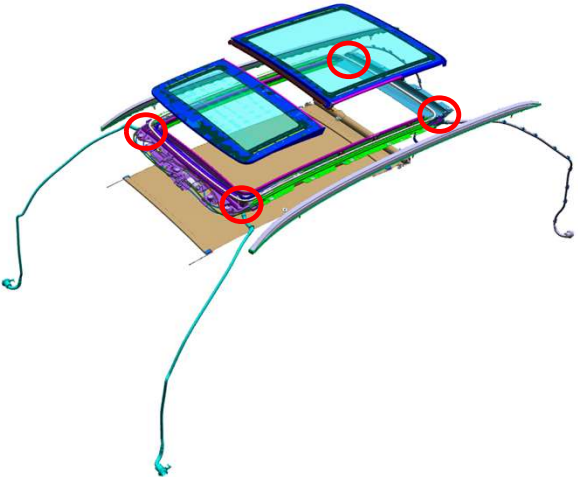
DRAIN TUBES CLOGGED (DIRT/DEBRIS)

Situation: There is a water leak onto the carpets. The drain tubes may be clogged.

Repair: Verify water flow through drain tube. Check for twist/kinks in drain hoses first. If no defect is found, gently blow air through drain tube to force debris to come out. Submit TSARA case for assistance if clog cannot be cleared.

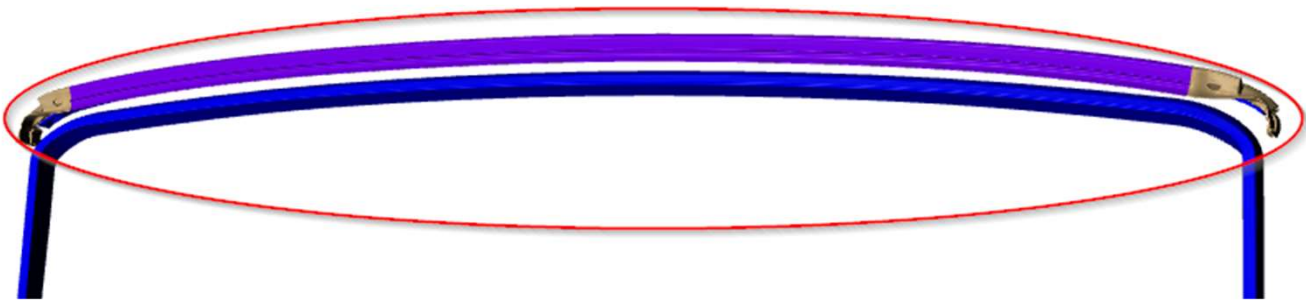
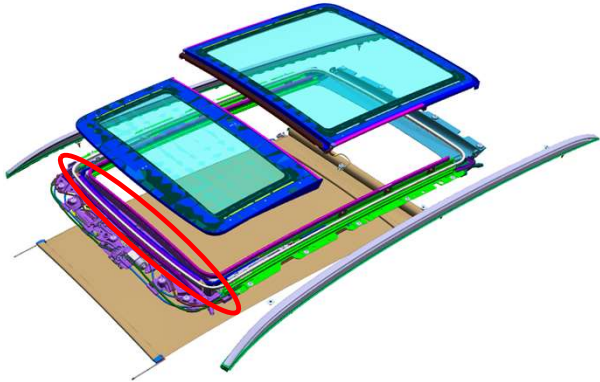
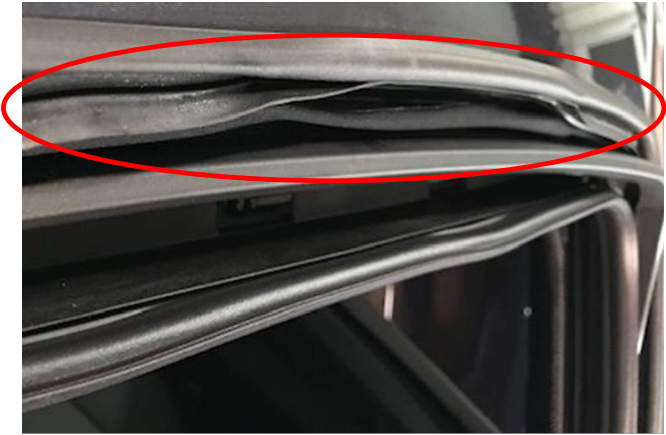
AERO ACOUSTIC SEAL NOT INSTALLED / STUCK

Situation: There is a water leak in the front. The aero-acoustic seal may be incorrectly installed or deformed.

Repair: Check if seal is properly seated and in good condition. If not, then reset or replace the aero-acoustic seal and replace the body seal according to ISTA/AIR instructions REP 54 13 055.

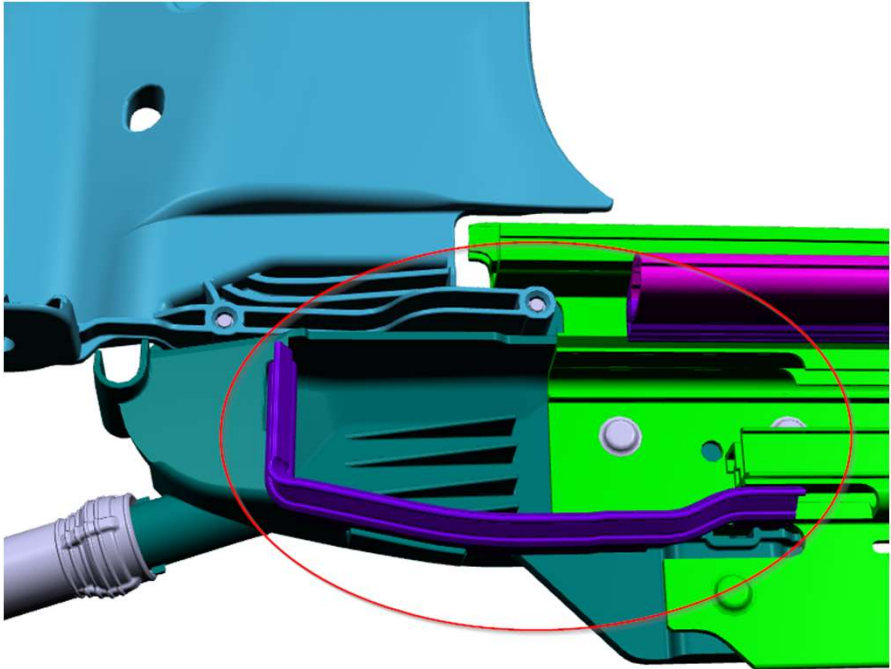
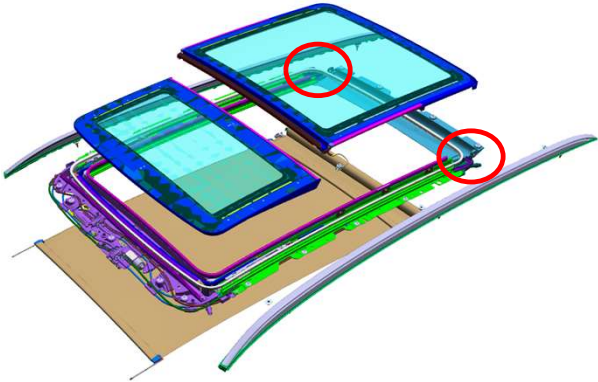
REAR BEAM DYKO SEAL NOT INSTALLED

Situation: There is water ingress in the trunk area. The rear beam seal may not be installed.

Repair: Check if seal is properly seated. Loosen bolts to lower the frame in order to properly inspect seal. If seal is completely missing then replace frame according to ISTA/AIR instructions REP 54 13 261.

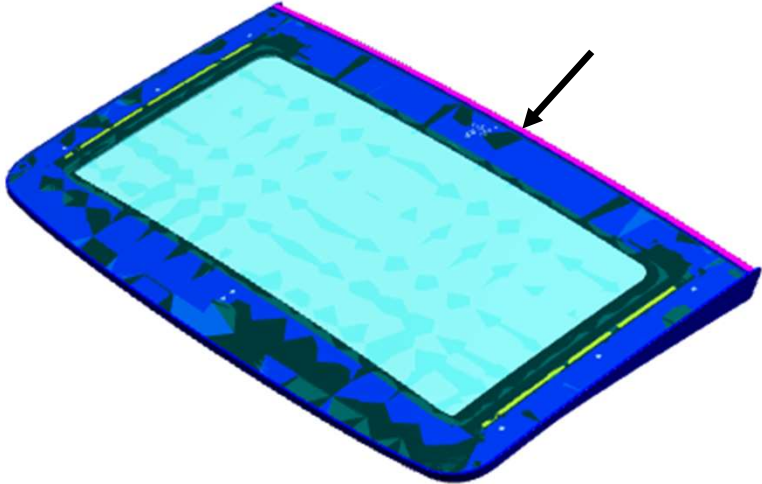
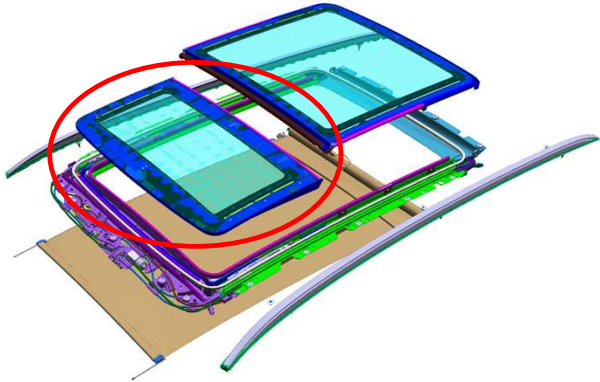
FRONT CENTER SEAL LOOSE/SHRINKING

Defect: separated

Defect: shrunken / gap

Situation: Wind noise heard at speeds of 30 Mph. A gap can be seen near the end of the seal on front glass.

Repair: Replace seal according to ISTA/AIR instructions REP 54 13 052. Refer to B54 04 21.

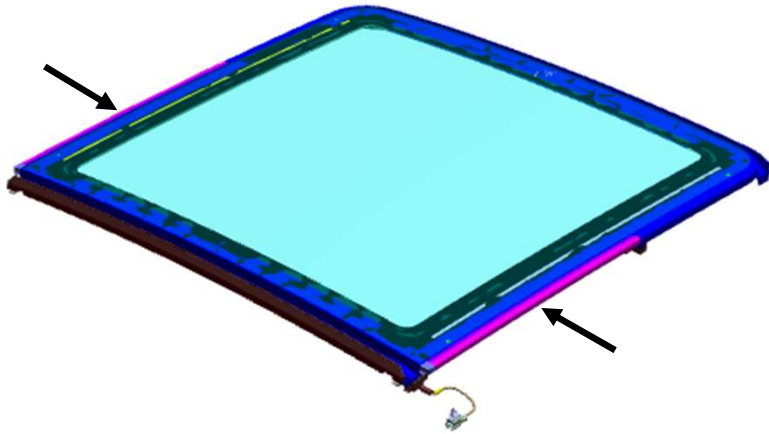
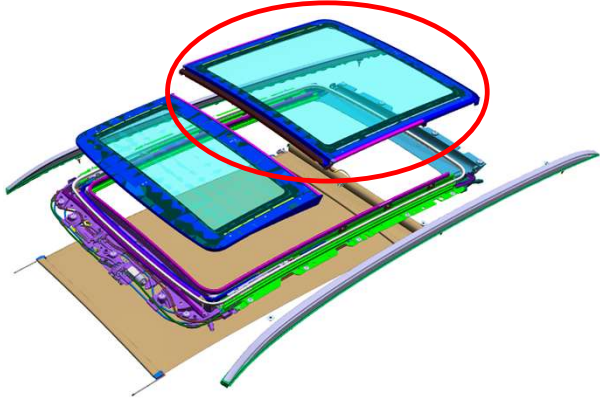
SIDE SEAL LOOSE/SHRINKING

Situation: Wind noise heard at speeds of 30mph.
Repair: Look for gap near ends or twist in seal. If found, replace seal according to ISTA/AIR instructions.
REP 54 13 050

example: gap

example: twist

example: loose

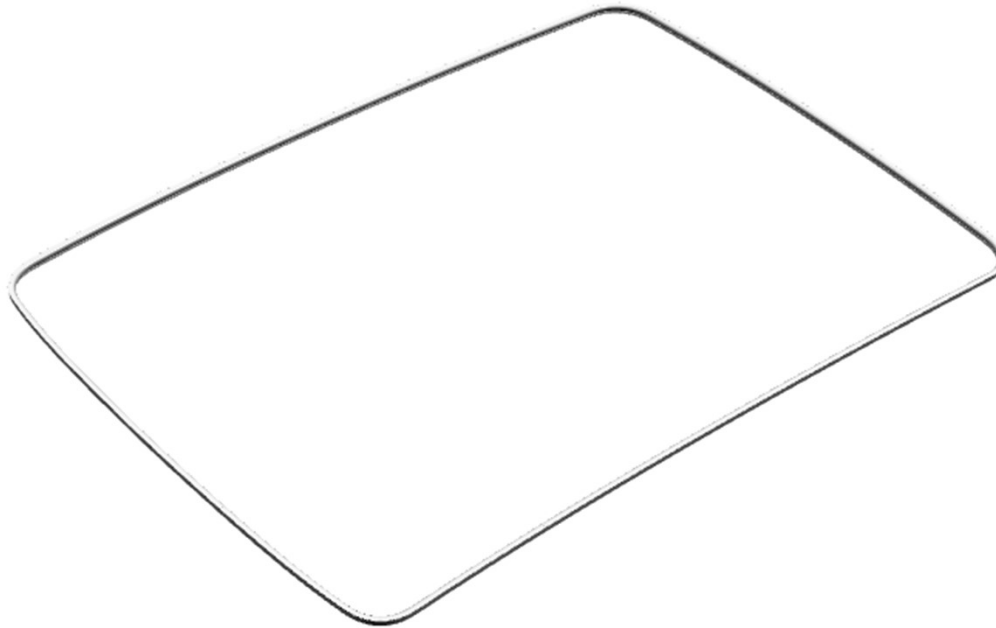
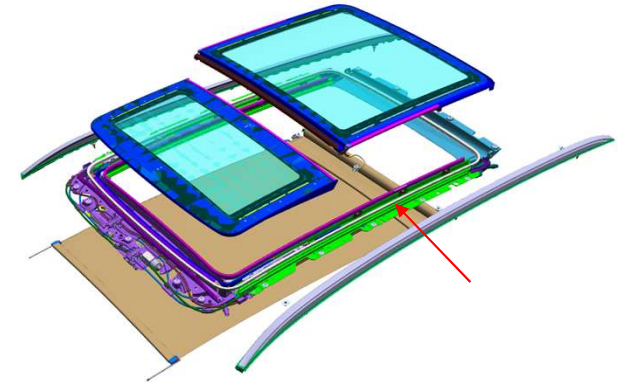
BODY SEAL NOT ATTACHED

example: gap/not flush

Situation: The body seal may be detached or improperly installed.

Repair: Check body seal to see if it is flush to vehicle. (no loose areas/wrinkles)

If damaged, replace body seal according to ISTA/AIR instructions REP 54 13 055.

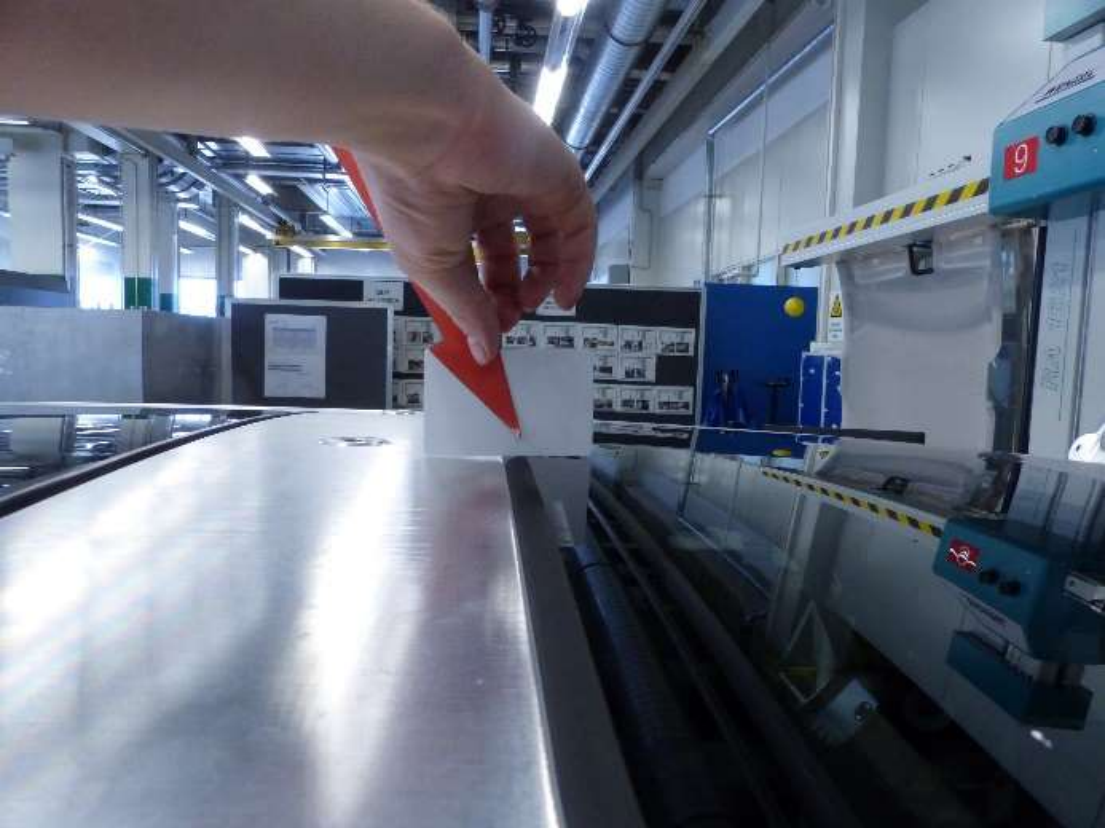
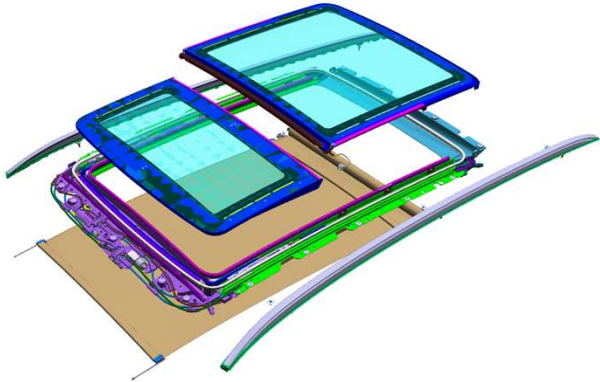
GLASS NOT FLUSH

Situation: Rushing wind noise is heard from center of the glass.

Repair: Tape can be used to isolate noise and find where glass is not flush.

Adjust both sunroof glass panels according to ISTA/AIR instructions REP 54 13 002.

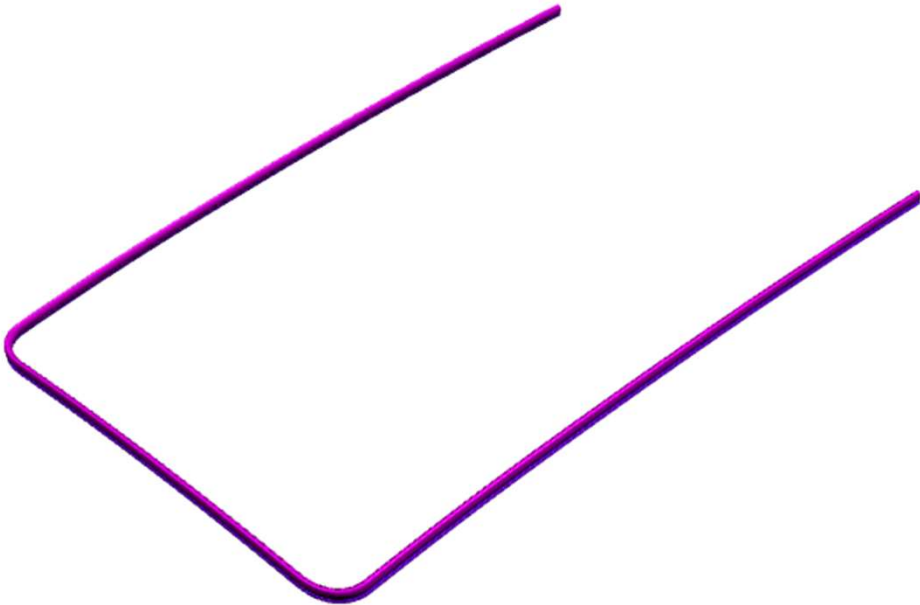
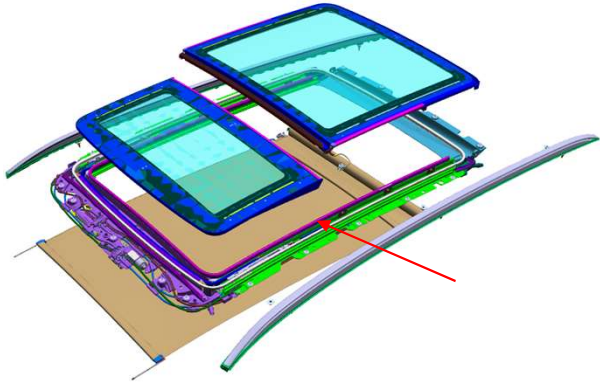
ACOUSTIC SEAL LOOSE

Situation: Rattle or groaning noise heard while driving over rough road surfaces. Upwards pressure on the glass will stop the noise. The cause is interference between the sunroof glass and acoustic seal mounted to the sunroof frame (not the roof perimeter seal).

Repair: Slightly lower glass (within specification) to increase pressure between the glass and the seal.

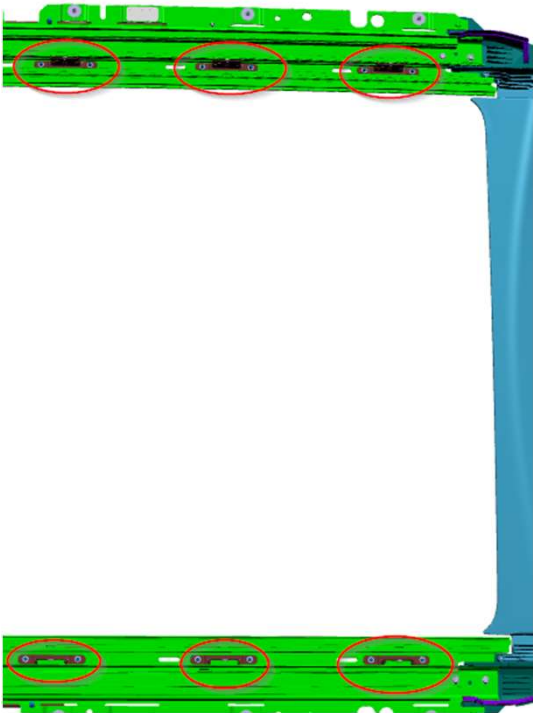
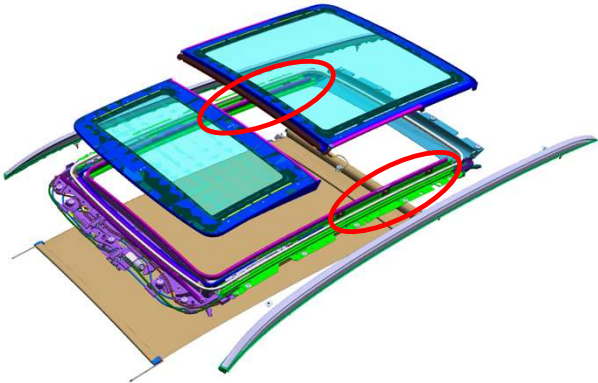
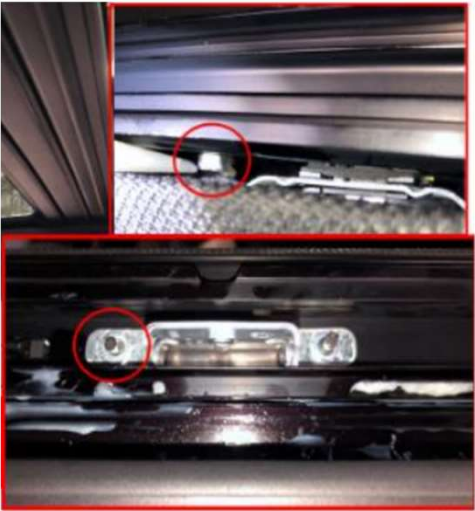
REAR GLASS BRACKET LOOSE

Situation: Metallic noise heard while driving over rough road surfaces.

Repair: Inspect bracket screws (**Bracket to frame**, not glass to bracket). Check for any cross threaded screws. If cross threaded screws are found then replace screws. If screws can't be tightened correctly, the frame would need replacement.

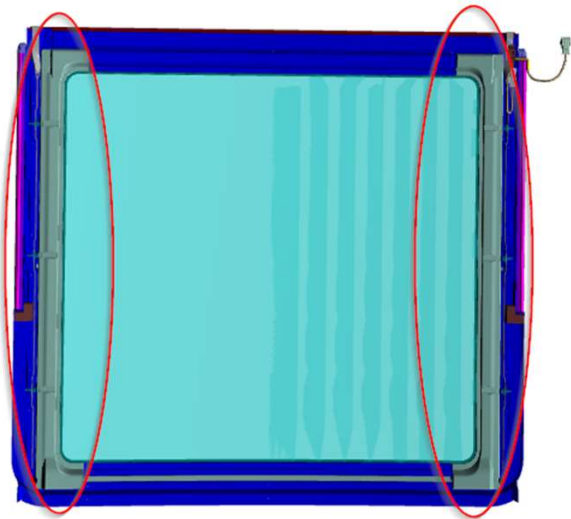
AMBIENT LIGHT COVERS LOOSE

Situation: Rattle is heard from plastic cover tapping on glass panel (front or rear glass) when driving on rough road surfaces.

This situation only affects vehicles with SA407 (Panoramic Sky Lounge LED Roof)

Repair: Attempt to insulate with felt tape is visually appropriate. Replace glass panel according to ISTA/AIR instructions REP 54 13 250 if insulation is not possible.

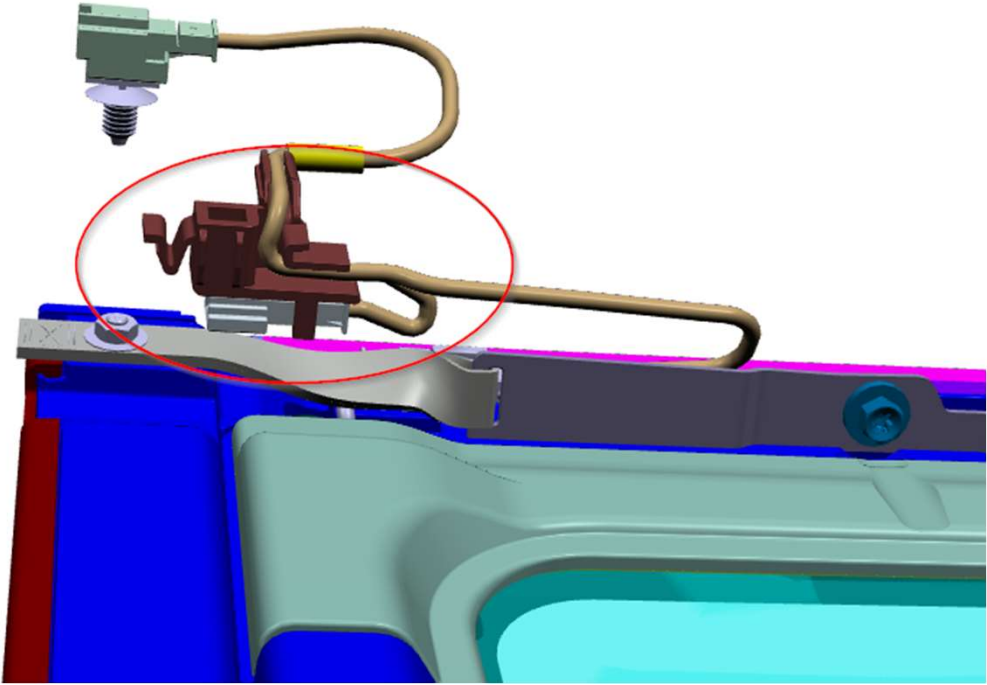
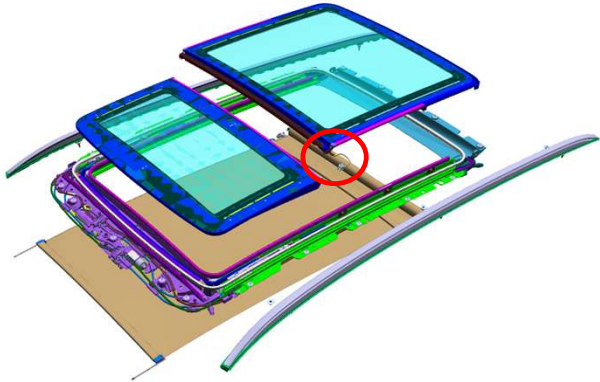
AMBIENT LIGHT CLIP LOOSE/NOT INSTALLED

Situation: A loose clip for the ambient light harness is tapping on the glass or contacting the sunroof mechanism. Only affects vehicle with SA407 (Panoramic Sky Lounge LED Roof).

Repair: Correctly install the harness clip.

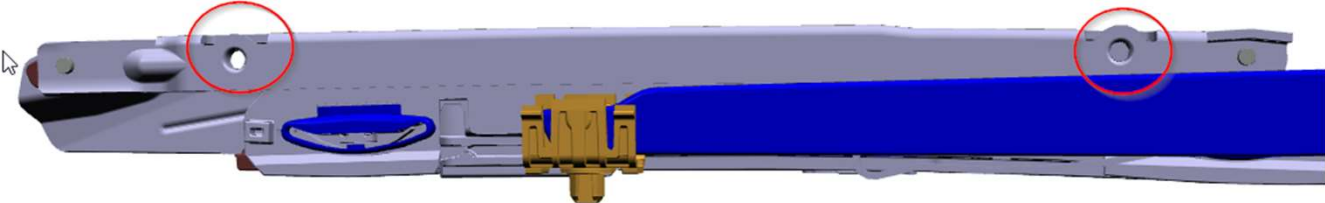
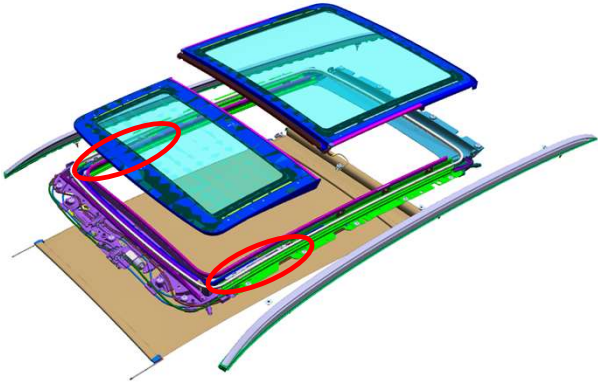
EXTRA SCREW

Situation: A metallic “rolling” noise is heard during acceleration/deceleration. An extra screw may have fallen into the track during production. The screw is not missing from any location.

Repair: Remove the extra screw. Additional repairs are not necessary, all other screws are correctly installed.

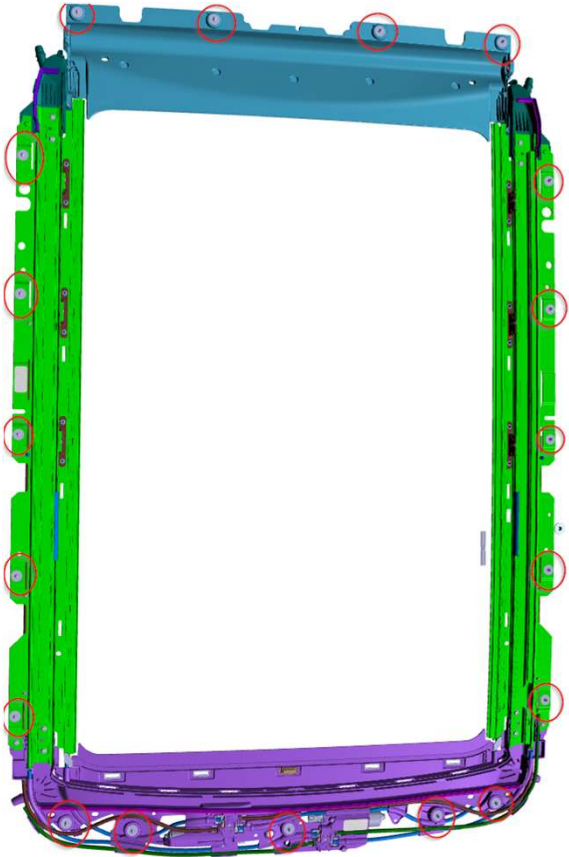
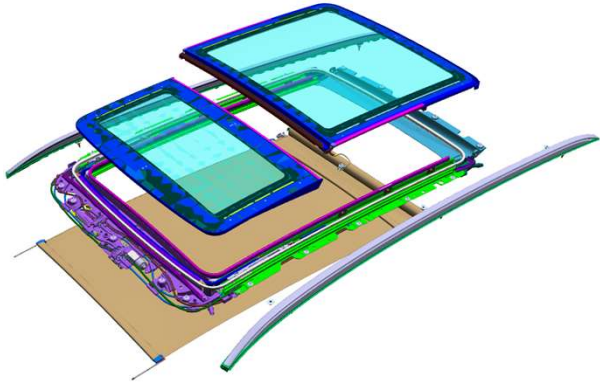
LOOSE SCREW

Situation: Rattling noise is heard from the roof area. One or more sunroof frame screws may be loose.

Note: 1 under torqued screw is unlikely to cause a noise. Fully investigate to ensure loose screws are the only cause. Attempt to measure torque if not correct and provide feedback via INFO case.

Repair: Inspect screws for signs of cross-threading. Replace screws if damaged. Retorque frame screws correctly according to ISTA/AIR repair instructions to 5.4nm. Retorque glass panel screws to 4.5nm.

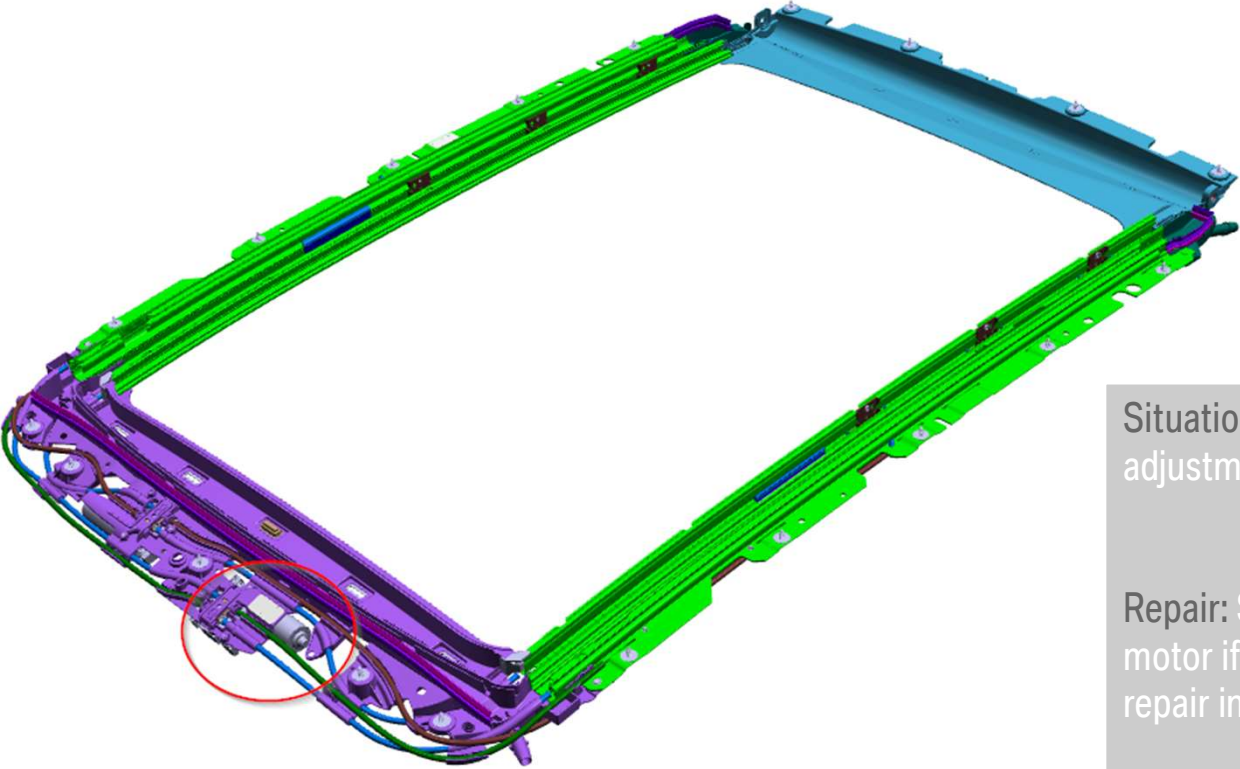
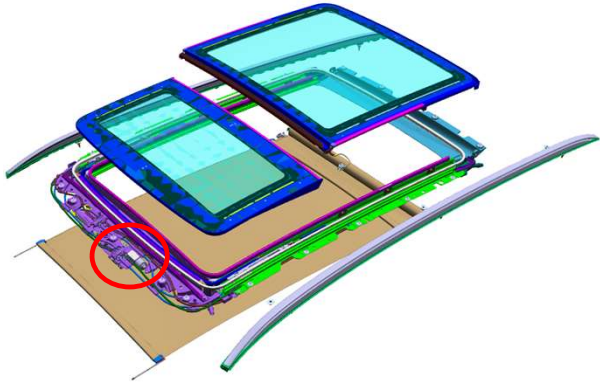
MOTOR NOISE

Situation: An oscillation noise is present from the adjustment motor when the shade or glass is moving.

Repair: Swap/replace the motor and retest. Replace the motor if found to be the cause according to ISTA/AIR repair instruction REP 67 61 580.

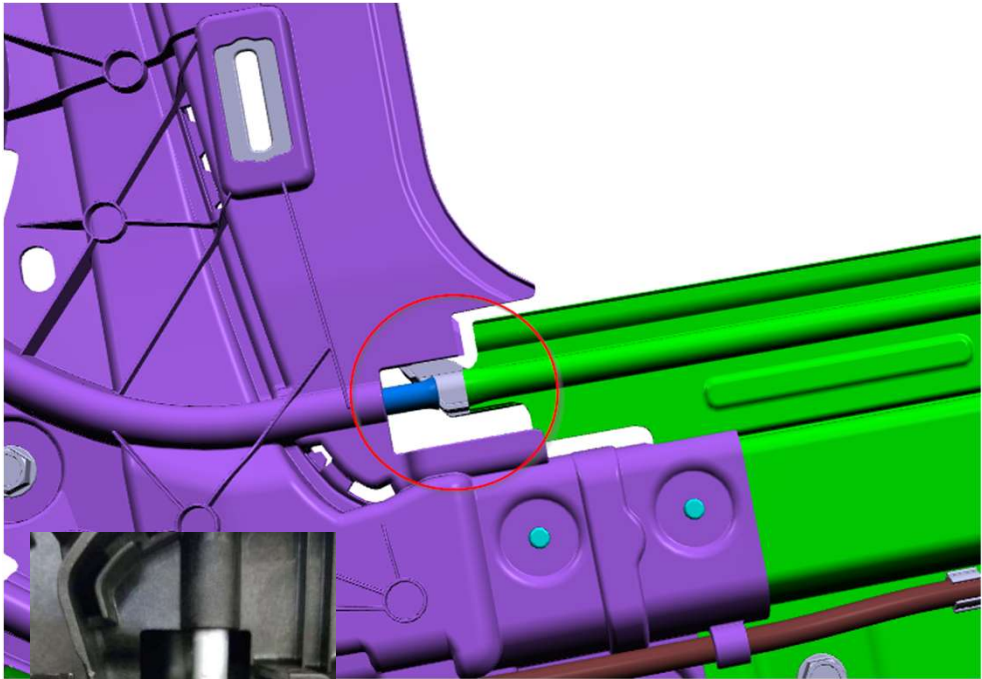
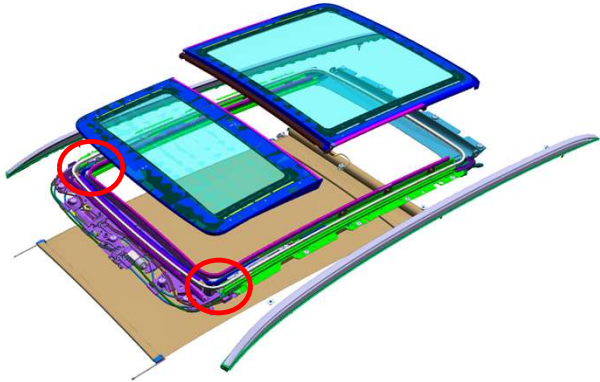
CABLE RATCHETING

Defect: misaligned or burr

Situation: A quiet oscillating/chattering noise is present when moving only the sunshade.

Repair: Inspect the sunroof frame for misalignment or a burr on the cable guide as shown. If damage is found, replace the frame according to ISTA/AIR instructions REP 54 13 261.

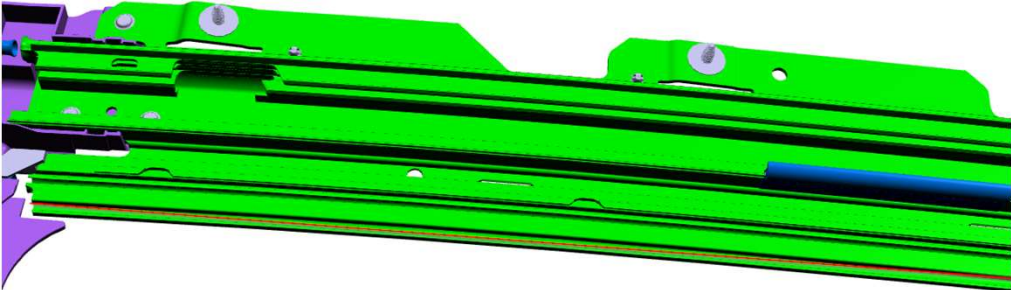
GUIDE RAIL NOT ENOUGH LUBRICATION

Situation: A squealing or chattering noise is heard when moving the sunshade. Typically on Alcantara (suede) equipped vehicles.

Repair: Clean and lubricate the sunroof guides. If noise persists then replace sunshade according to ISTA/AIR instructions REP 54 13 548.

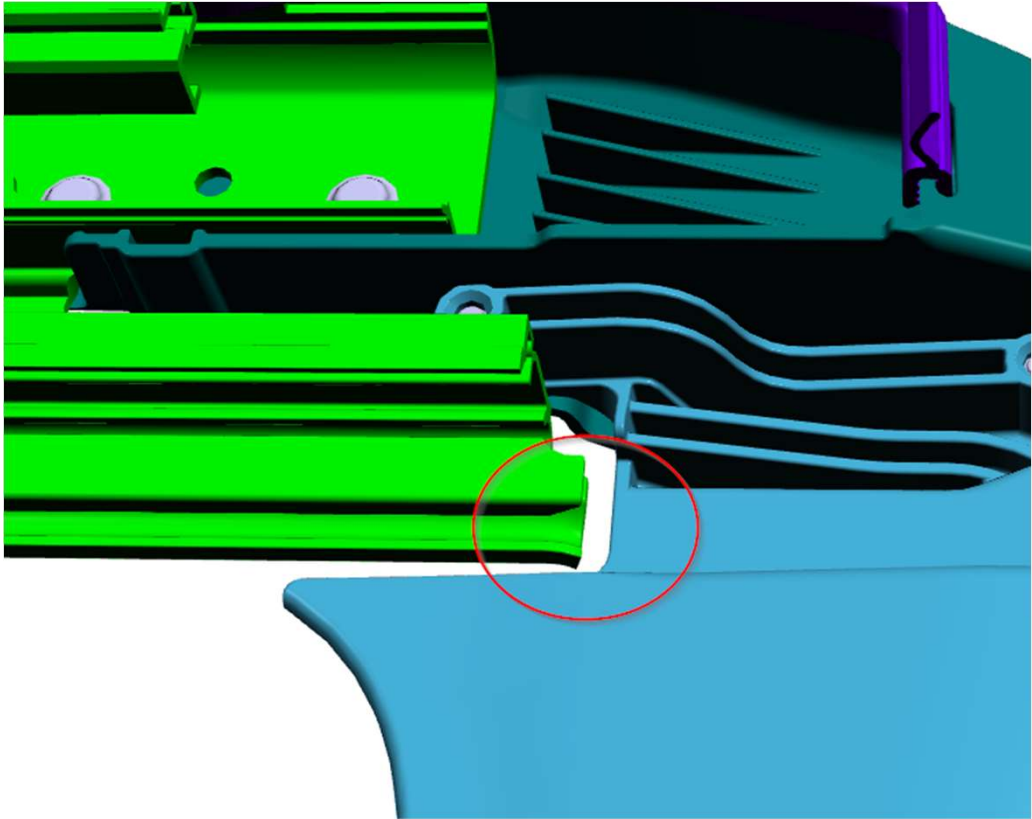
PDF RAIL BURR

Situation: A scratching/catching noise is heard while shade is moving.

Repair: Replace frame according to ISTA/AIR instructions REP 54 13 261.
