SUNROOF DIAGNOSIS WHAT IS THE ISSUE?

WATER LEAKS

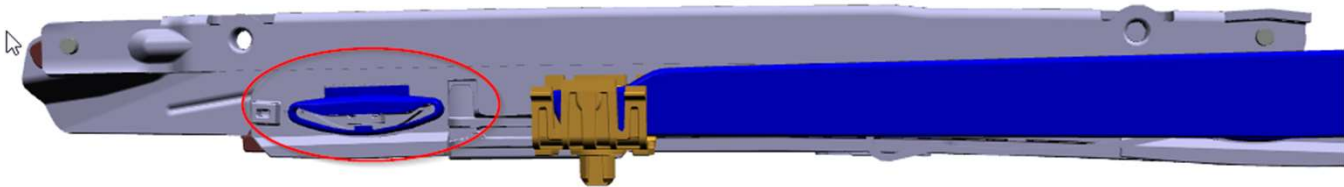
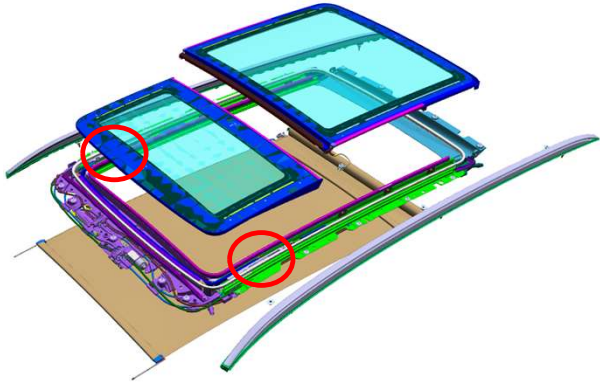
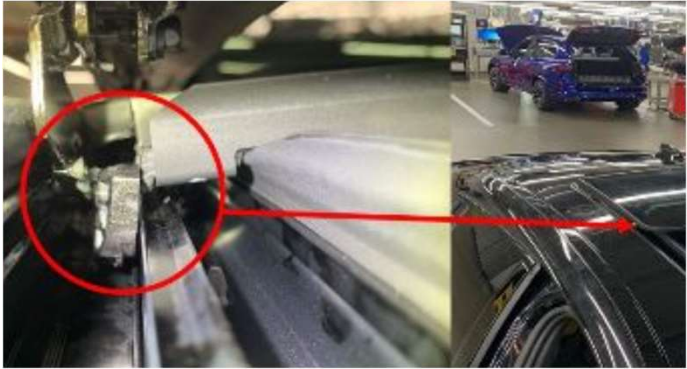
GUIDE SHOE NOT INSTALLED CORRECTLY

Situation: A rubbing/tapping noise heard when glass is moved.

Repair: Replace mechanism according to ISTA/AIR instructions REP 54 13 515.

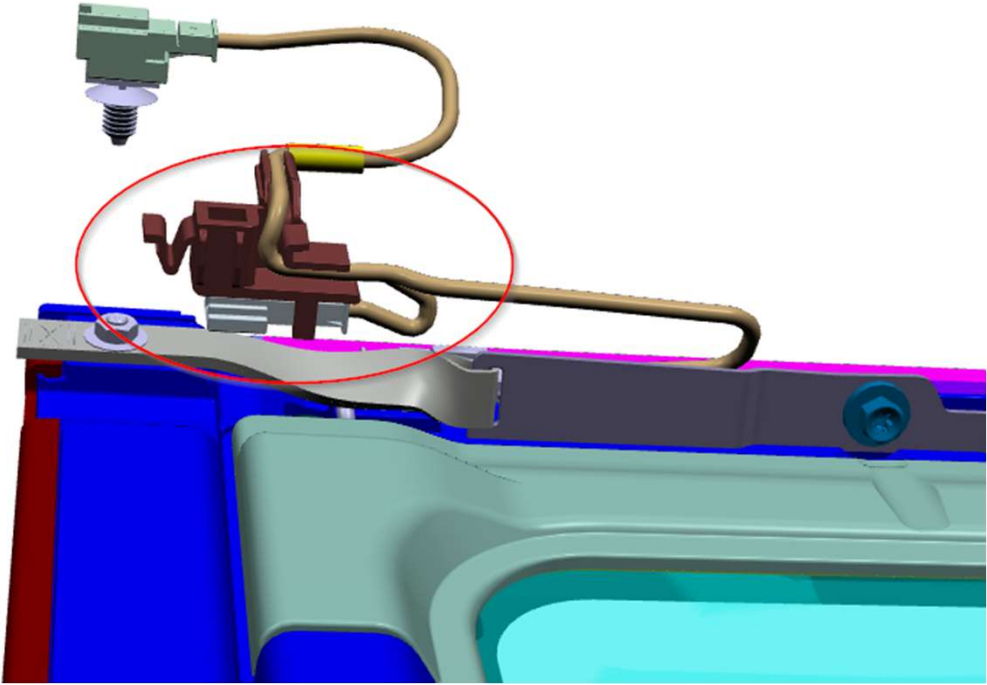
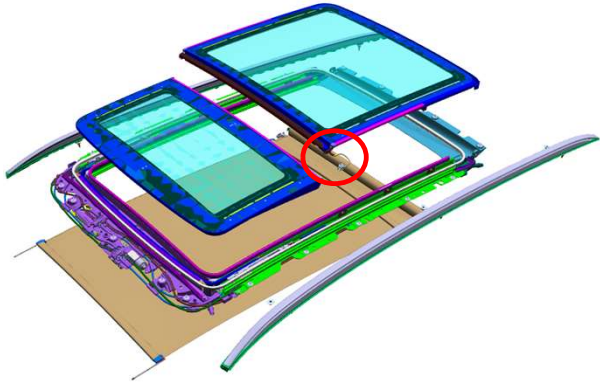
AMBIENT LIGHT CLIP LOOSE/NOT INSTALLED

Situation: A loose clip for the ambient light harness is tapping on the glass or contacting the sunroof mechanism. Only affects vehicle with SA407 (Panoramic Sky Lounge LED Roof).

Repair: Correctly install the harness clip.

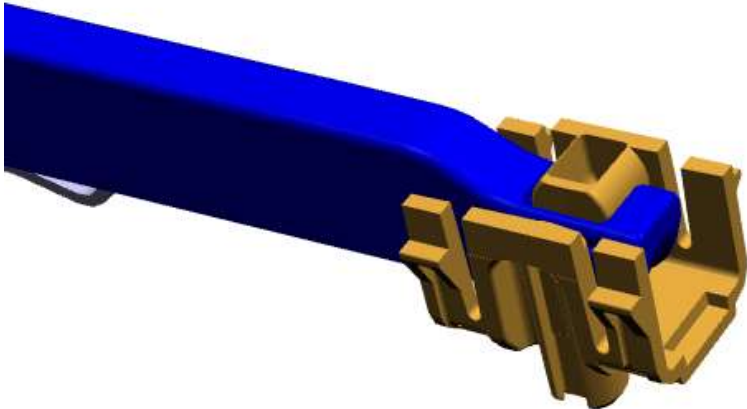
WIND DEFLECTOR PIVOT POINT LOOSE/BROKEN

Situation: A creaking noise is present while the wind deflector raises/lowers. Sunroof may reverse due to anti-trap when closing.

Repair: Replace pivot point and wind deflector according to ISTA/AIR instructions REP 54 13 090

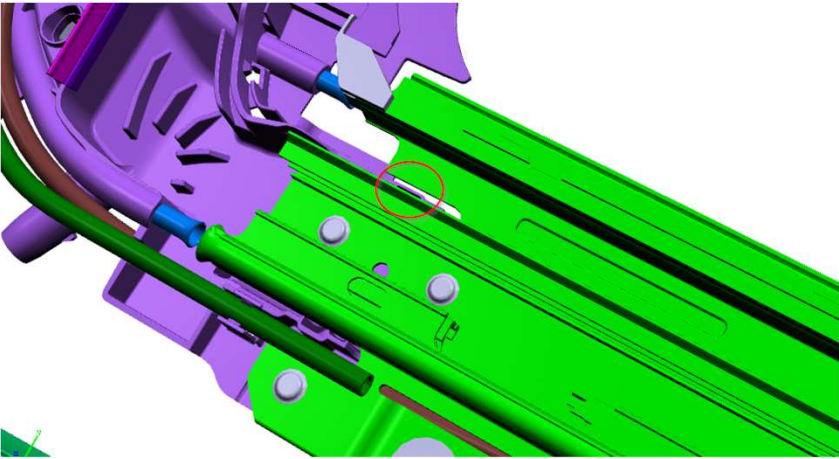
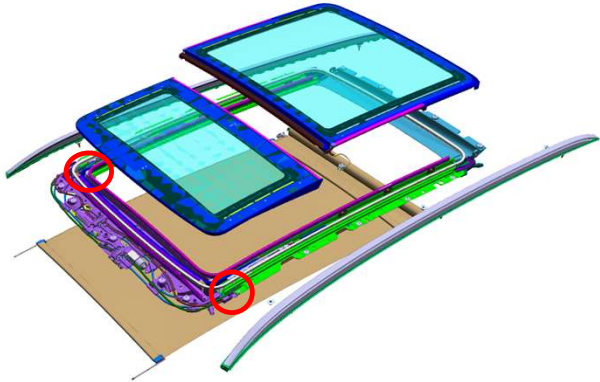
WIND DEFLECTOR EXCESS BUTYL

Picture of NOK (Before adjustment)

Picture of OK (After adjustment)

Situation: A popping noise is heard when the wind deflector raises/lowers.

Repair: Remove excess butyl to allow the wind deflector to move freely.

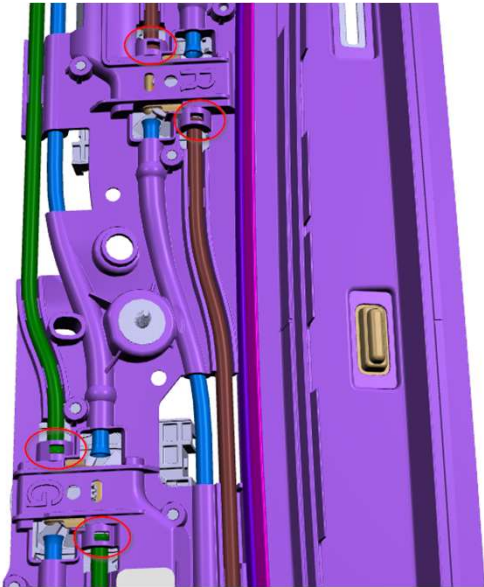
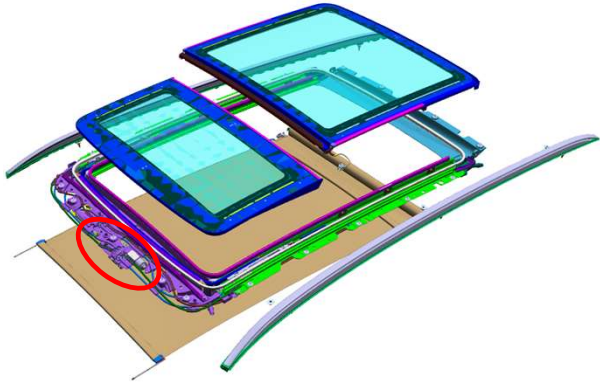
RELIEF CABLE TUBE NOT INSTALLED

Situation: A humming / crackling noise is present when opening the glass or sunshade.

Repair: Replace frame according to ISTA/AIR instructions REP 54 13 261.

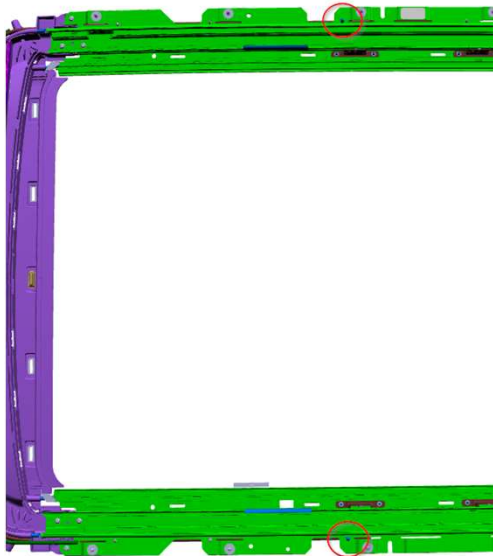
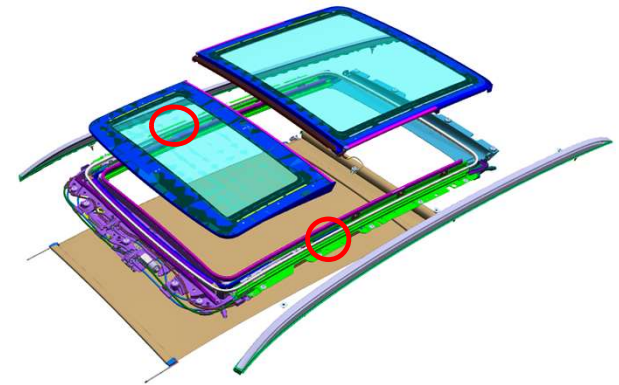
CABLE TUBE CLIP NOT INSTALLED

Situation: A humming / crackling noise is present when opening the sunshade. Or, a plastic rattling noise is heard while driving on rough road surfaces.

Repair: Reinstall the guide tube clip into the frame. If tube is damaged and noise persists then replace the frame according to ISTA/AIR instructions REP 54 13 261.

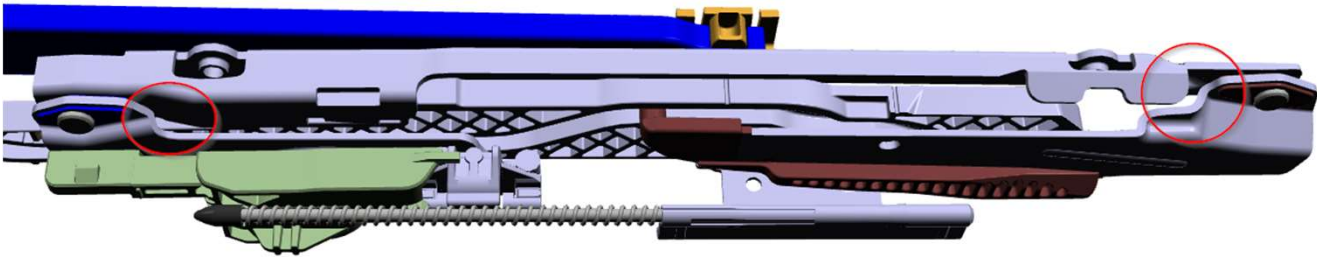
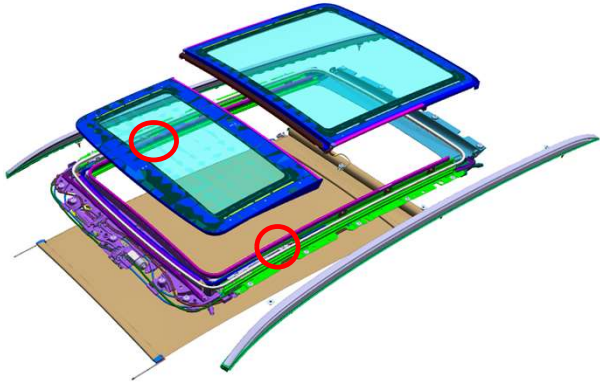
MECHANIC ARM BURR

Situation: A clicking sound is present when the glass is opened to vent.

Repair: Inspect the pivot area for a burr and remove it if found. If burr is not found then replace the sunroof mechanisms according to ISTA/AIR instructions REP 54 13 515.
