[BMW F25 X3 28iX SAV](#) / [Non-electrical diagnosis](#) / [03 Body](#) / [01 Noise](#) / [Noise of doors](#) / [Repair instructions F25](#) /

51 32 420 Removing and installing/replacing trim cover on front door window frame, left or right

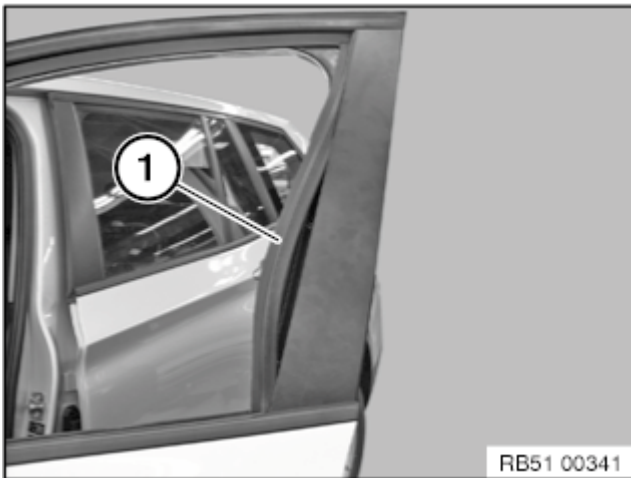
Pull rubber window seal (1) out of rear window guide. *Installation note:* Moisten rubber window seal (1) slightly with water to facilitate installation.

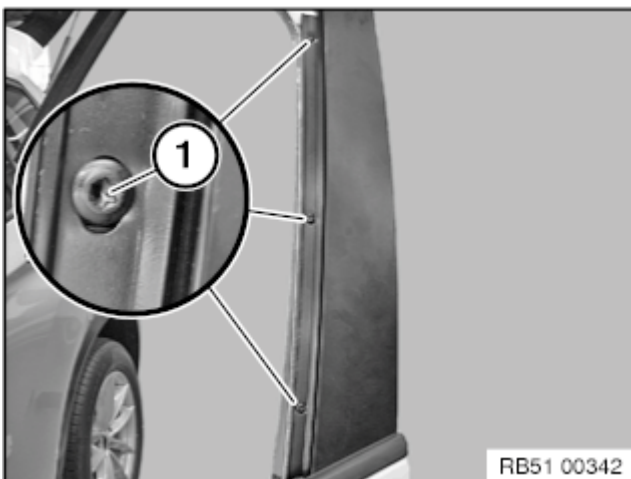
Release screws (1).

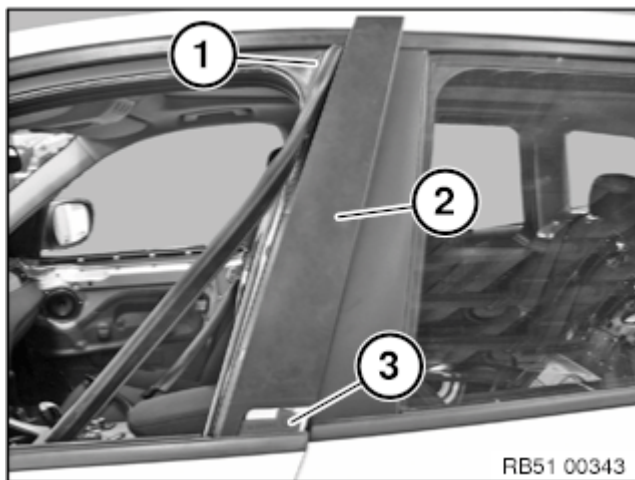
Push trim cover on window frame (2) down slightly until it can be fed out at the top at the rubber window seal (1).

Now carefully pull out trim cover at window frame (2) upwards and toward the rear.

Installation note:

Sealing on end plate of B-pillar (3) must not be damaged or missing.

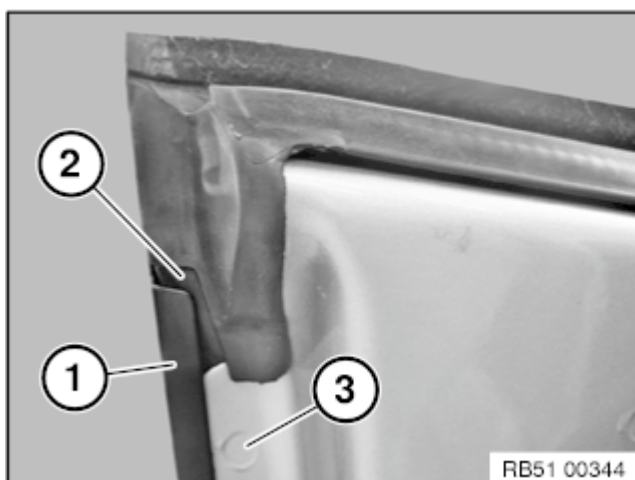
Installation note:

Correctly slide trim cover on window frame (1) over sheet metal edge (3) and rubber window seal (2).
