SIB 11 03 17

## N20 AND N26 ENGINE TIMING CHAIN AND OIL PUMP DRIVE CHAIN: LIMITED WARRANTY EXTENSION

This Service Information Bulletin (Revision 10) replaces SI B11 03 17 **dated August 2021**.

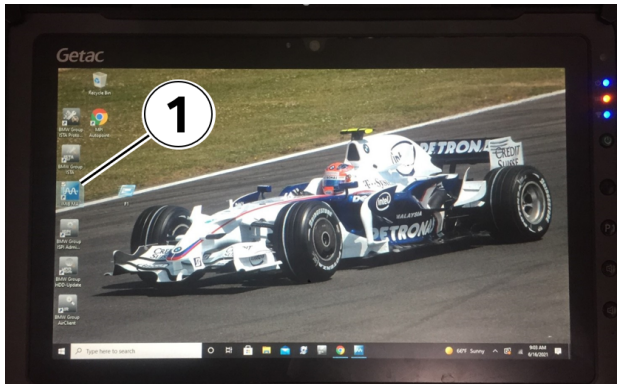
<p>2. Go to the IMIB Next screen and open the “IMIB MA” application (1).</p>

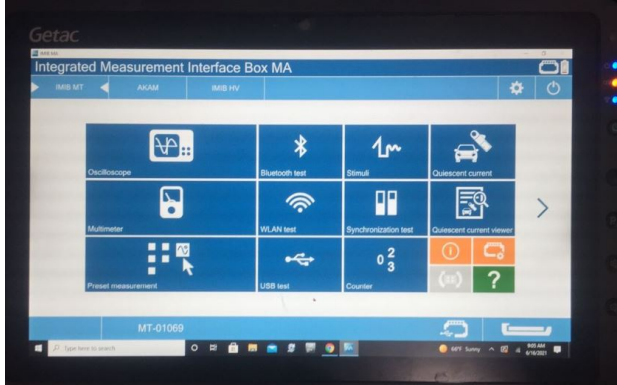
<p>3. After the IMIB MA application opens then return to ISTA and continue diagnosis.</p> <p><b>The test plan “Evaluating the drive chain for the oil pump” will not operate if the IMIB MA application is not open yet.</b></p>

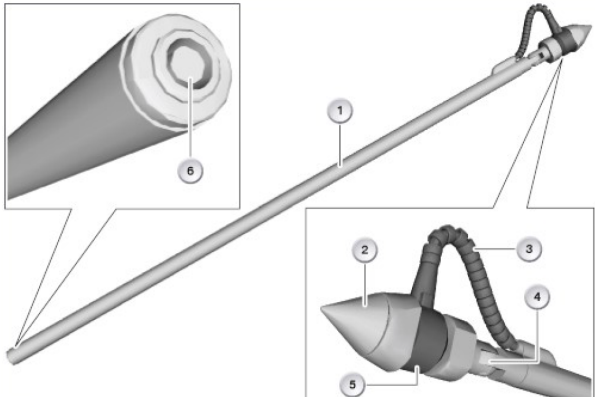
<p>Measuring adapter special tool P/N 2405341 (1)</p> <p>Measuring adapter tip (2)</p> <p>Sensor cable (3)</p> <p>Adjustable joint (4)</p> <p>Frequency sensor (5)</p> <p>7-pin IMIB cable connection (6)</p>
---	---

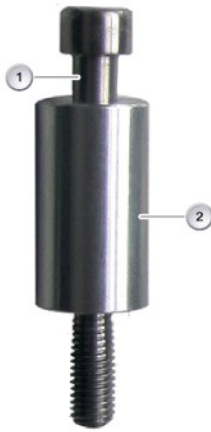
Frequency sensor mounting bolt and spacer sleeve special tool P/N 5A1FAD0

Mounting bolt (1)

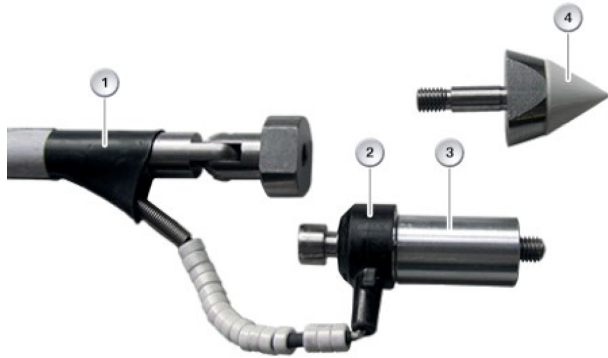
Tool set up and installation onto the engine:

Remove the measuring adapter tip (4)

Install the spacer sleeve and mounting bolt (3) through the frequency sensor (2).

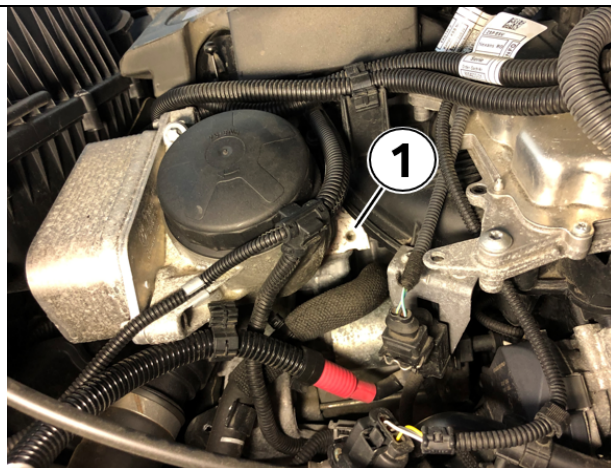
Remove the acoustic engine cover.

Locate the empty M8 threaded hole (1) in the cylinder head adjacent to the oil filter housing.

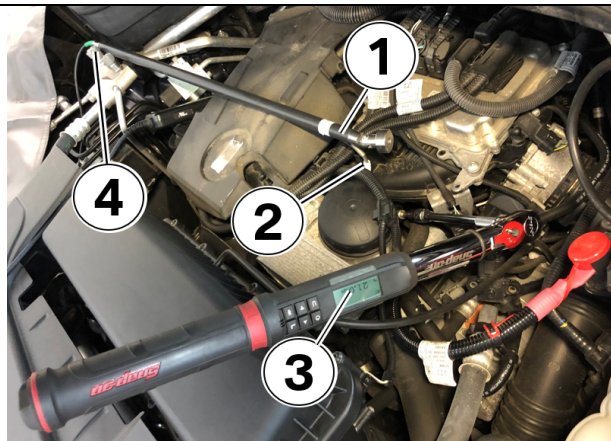
Install the frequency sensor with mounting bolt into the M8 hole (1).

Route the wire between the oil filter housing and intake manifold (2) to avoid damage to the tool.

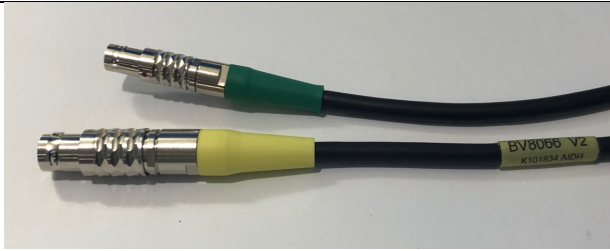
7 pin AUX measuring cable overview:

BMW Part Number - 81 31 2 468 790 – This 7 pin cable was sent with IMIB R2.

AVL SN 2297  
 BV8066 V2  
 K101834 AIDH

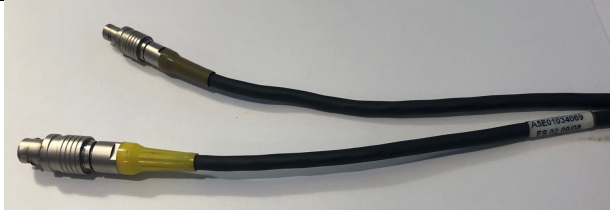
No BMW Part Number – This 7 pin cable was sent with IMIB.

Cable end colors: Yellow and Brown

Label Description on the Cable:

SIEMENS AUX1  
 A5E01034069  
 ES 02 09/08

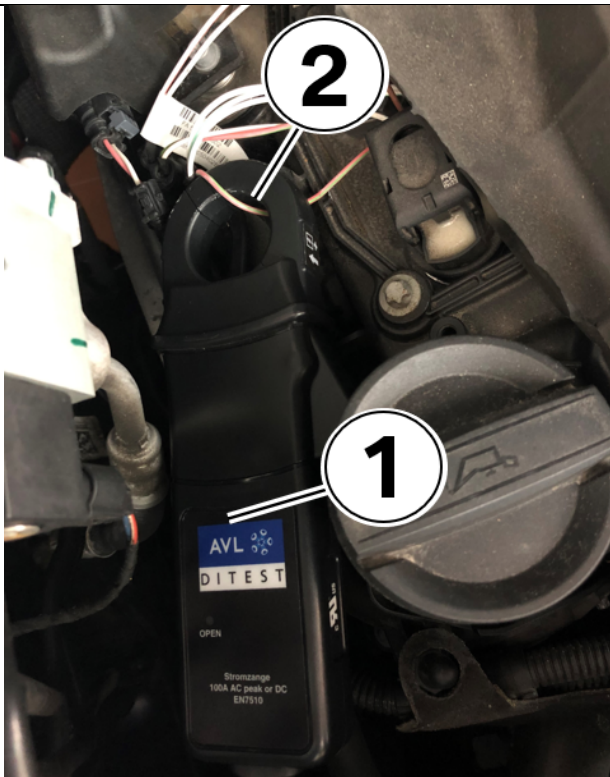
Connect the IMIB 100 AMP clamp (1) to the red/green wire of ignition coil #1 (2).

P/N 81 31 2 468 784  
 Or  
 P/N 81 31 2 344 255

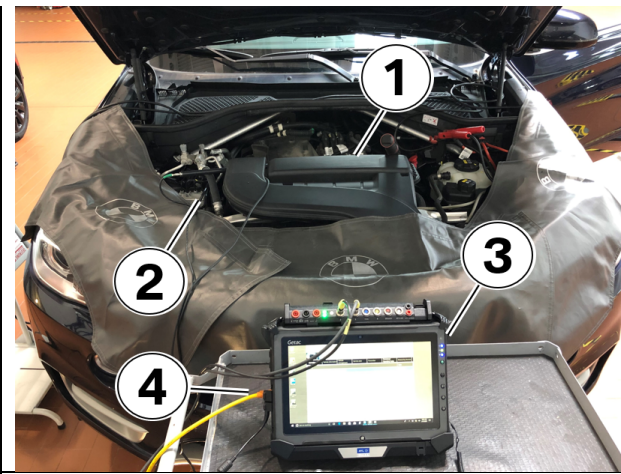
IMIB and vehicle overview:

Frequency sensor installed (1).

100 AMP clamp installed (2).

IMIB Next with tablet placed on a table or cart in front of the vehicle (3).

IMIB Next connect to the network via LAN (4).

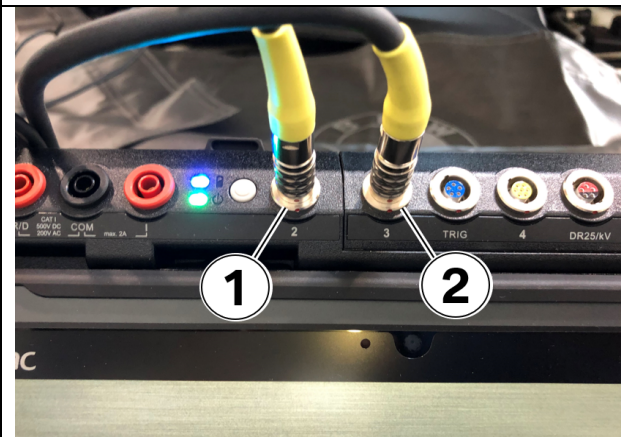
Connect the frequency sensor 7 pin AUX cable to port 2 on the IMIB next (1).

Connect the 100 AMP clamp 7 pin cable to port 3 on the IMIB next (2).

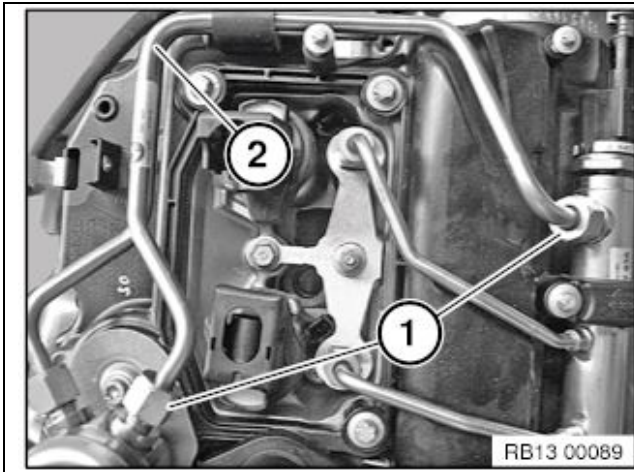
When the high-pressure line connections (1) are released then the line (2) must be replaced.

This high-pressure line must be replaced and cannot be re-used.

Refer to Repair Instruction 13 53 180 "Replace pressure line" for more details.
