SUNROOF DIAGNOSIS WHAT IS THE ISSUE?

WATER LEAKS

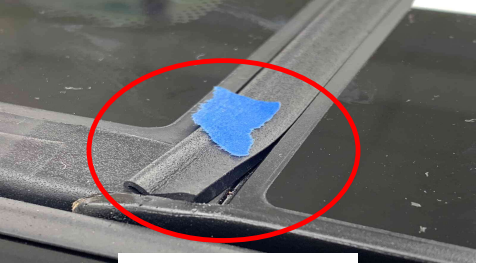
Defect: separated

Situation: Excessive water enters through the sunroof seals.

Repair: Look for gap near end of the seal on front glass. If found, replace seal according to ISTA/AIR instructions REP 54 13 052. Also refer to B54 04 21.

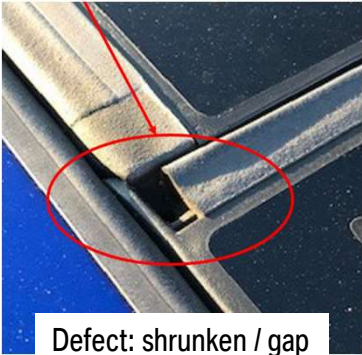
Defect: shrunken / gap

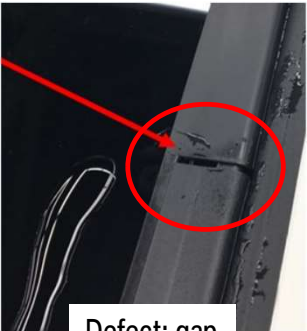
Defect: gap

Situation : Excessive water enters through the sunroof seals. (see pictures)

Repair: Look for gap near ends or twist in seal. If found, replace seal according to ISTA/AIR instructions.
REP 54 13 050

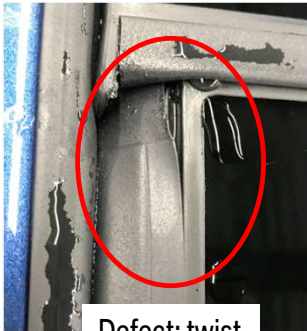
Defect: twist

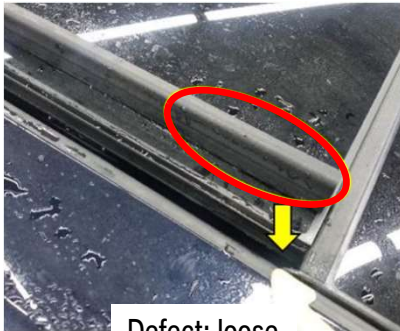
Defect: loose

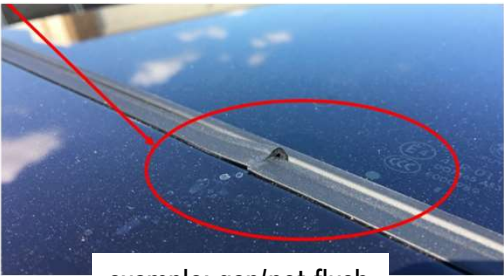
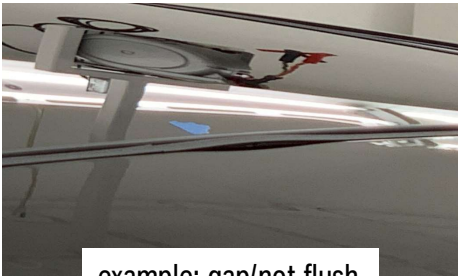
Situation : Excessive water enters through the sunroof seals.

example: gap/not flush

Repair: Inspect the sunroof perimeter seal for defects. Replace body seal according to ISTA/AIR instructions REP 54 13 055.

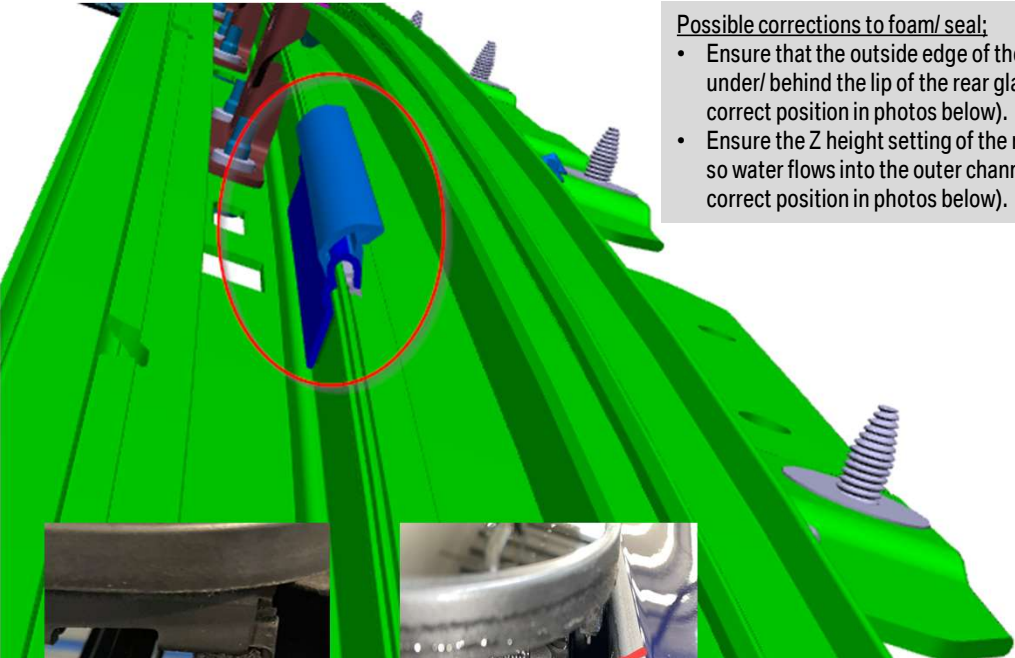
DYKO FOAM/SEAL- WATER INTRUSION INTO DRY SIDE OF CHANNEL

Solution: If there is a water leak near the middle drain channel, check position of the seal and foam.

(!) If NO foam/seal is present, the root cause of a water leak is NOT the foam/seal. Missing foam/seal will NOT CAUSE A WATER LEAK!! DO NOT REPLACE THE FFRAE FOR THIS.

- Possible corrections to foam/ seal;
- Ensure that the outside edge of the foam/ seal is tucked under/ behind the lip of the rear glass drain channel. (See correct position in photos below).
 - Ensure the Z height setting of the rear glass panel is correct so water flows into the outer channel of the cassette.(See correct position in photos below).

Repair: Check position of the seal/ foam. Remove foam/ seal if deformed or damaged.

Part Number: 9466049-02, if new rubber seal is not available it is approved to use the foam for repair.

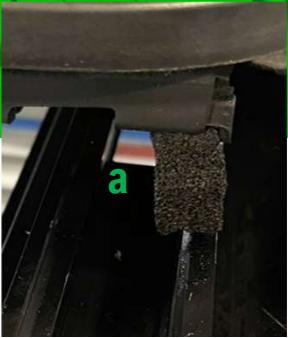
Correct foam position (a)

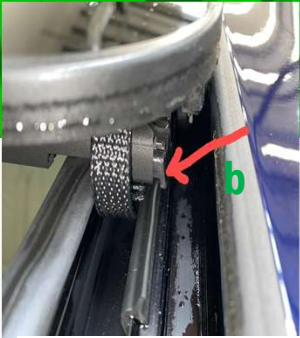
Correct seal position (b)

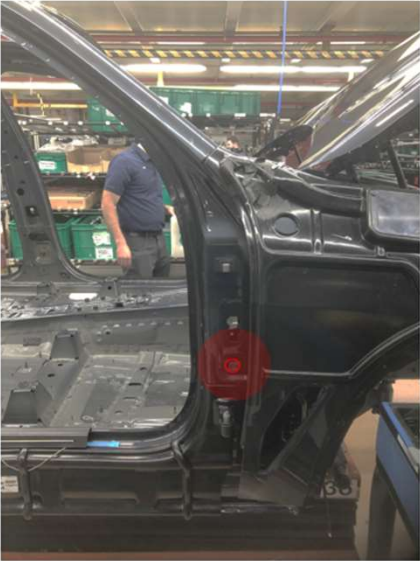
twisted

Situation: There is a water leak near the front or rear carpets. The drain tubes may be twisted. Remove A-pillar kick panels to check if front drain tube is twisted/kinked. Use borescope if needed.

Repair: Reposition hose to remove kink. If kink can't be removed, refer to B54 11 19 Attachment 1 for repair instructions.

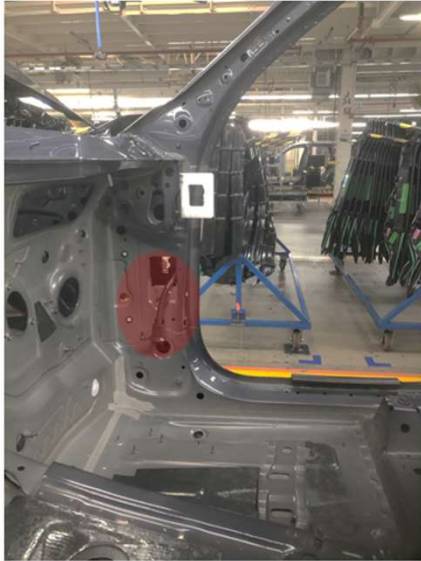
kinked

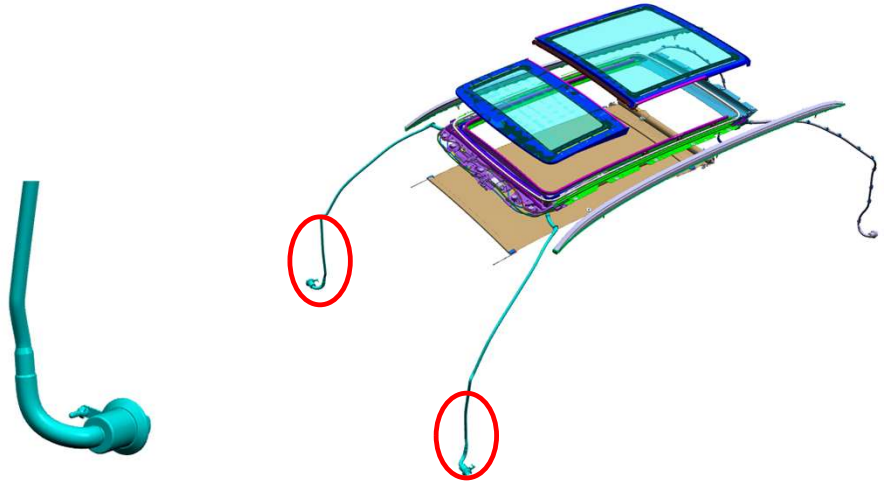
Slightly kinked

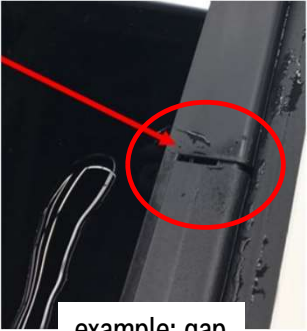
Situation: Wind noise heard at speeds of 30mph.
Repair: Look for gap near ends or twist in seal. If found, replace seal according to ISTA/AIR instructions.
REP 54 13 050

example: gap

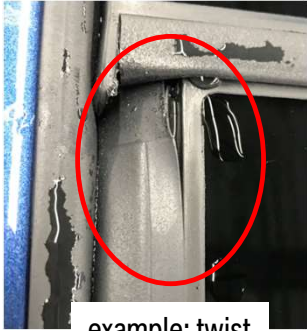
example: twist

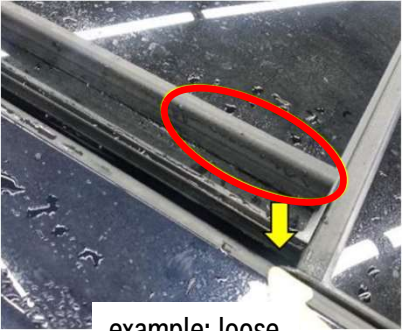
example: loose

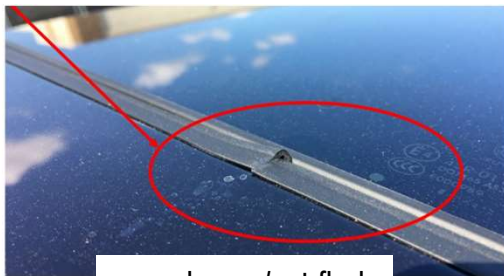
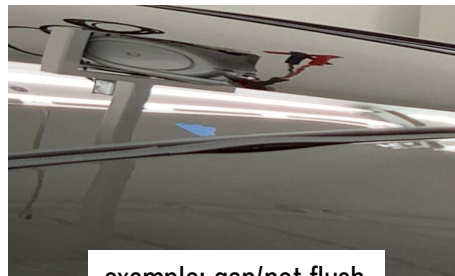
example: gap/not flush

Situation: The body seal may be detached or improperly installed.

Repair: Check body seal to see if it is flush to vehicle. (no loose areas/wrinkles)

If damaged, replace body seal according to ISTA/AIR instructions REP 54 13 055.

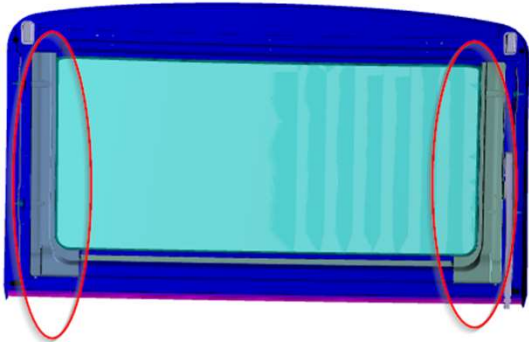
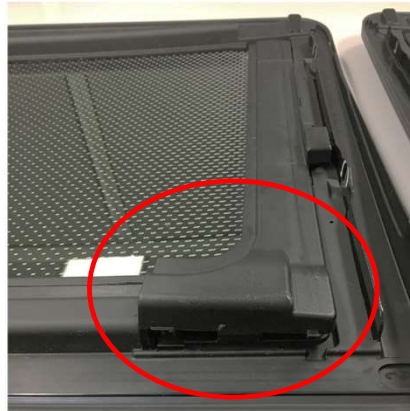
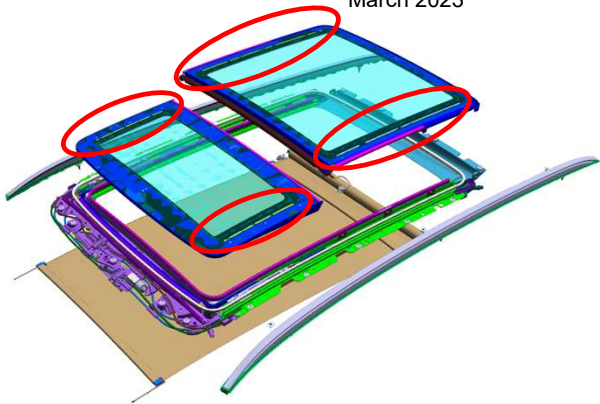
Situation: Rattle is heard from plastic cover tapping on glass panel (front or rear glass) when driving on rough road surfaces.

This situation only affects vehicles with SA407 (Panoramic Sky Lounge LED Roof)

Repair: Attempt to insulate with felt tape is visually appropriate. Replace glass panel according to ISTA/AIR instructions REP 54 13 250 if insulation is not possible.

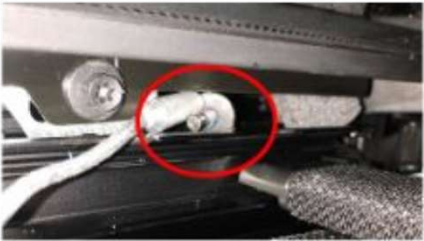
Situation: A metallic “rolling” noise is heard during acceleration/deceleration. An extra screw may have fallen into the track during production. The screw is not missing from any location.

Repair: Remove the extra screw. Additional repairs are not necessary, all other screws are correctly installed.

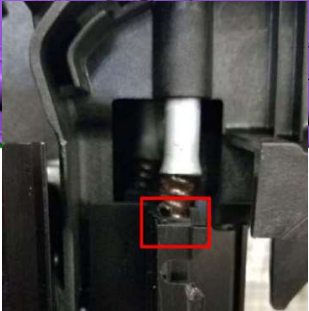
Defect: misaligned or burr

Situation: A quiet oscillating/chattering noise is present when moving only the sunshade.

Repair: Inspect the sunroof frame for misalignment or a burr on the cable guide as shown. If damage is found, replace the frame according to ISTA/AIR instructions REP 54 13 261.

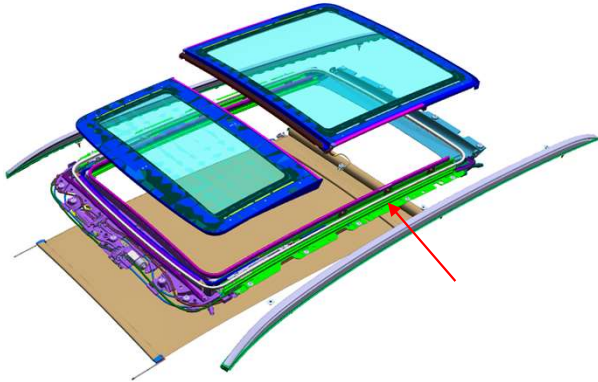
Situation: A squealing or chattering noise is heard when moving the sunshade. Typically on Alcantara (suede) equipped vehicles.

Repair: Clean and lubricate the sunroof guides. If noise persists then replace sunshade according to ISTA/AIR instructions REP 54 13 548.

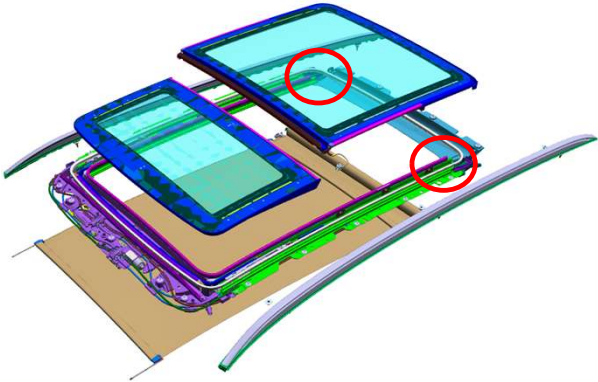
Situation: A scratching/catching noise is heard while shade is moving.

Repair: Replace frame according to ISTA/AIR instructions REP 54 13 261.

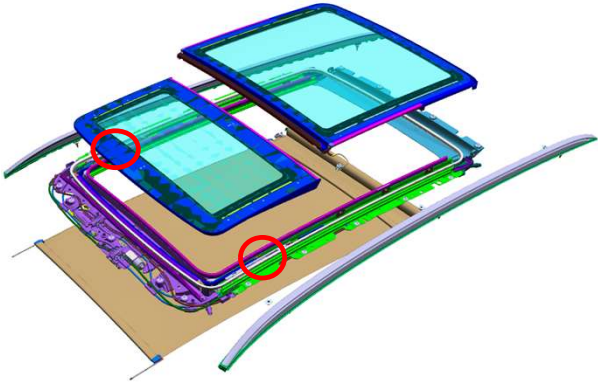
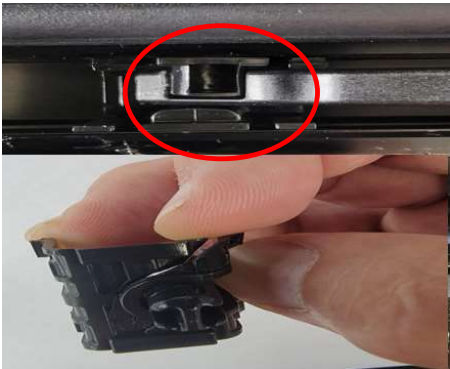
Situation: A creaking noise is present while the wind deflector raises/lowers. Sunroof may reverse due to anti-trap when closing.

Repair: Replace pivot point and wind deflector according to ISTA/AIR instructions REP 54 13 090

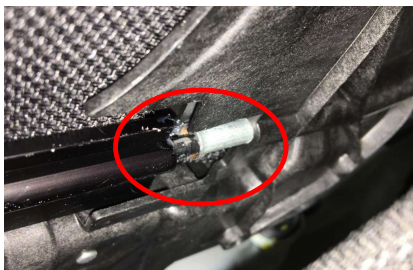
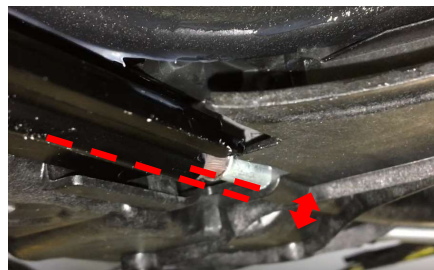
Situation: A humming / crackling noise is present when opening the sunshade. Or, a plastic rattling noise is heard while driving on rough road surfaces.

Repair: Reinstall the guide tube clip into the frame. If tube is damaged and noise persists then replace the frame according to ISTA/AIR instructions REP 54 13 261.

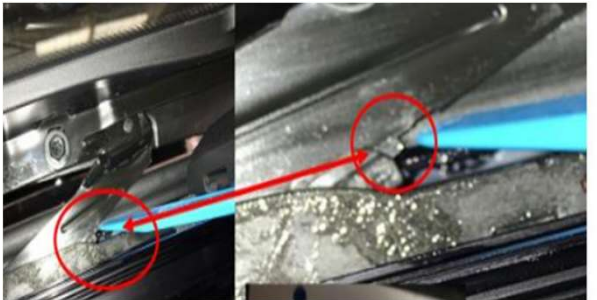
Situation: A clicking sound is present when the glass is opened to vent.

Repair: Inspect the pivot area for a burr and remove it if found. If burr is not found then replace the sunroof mechanisms according to ISTA/AIR instructions REP 54 13 515.
