[BMW F25 X3 28iX SAV / Repair Manuals and Technical Data / 22 Engine and transmission mounting / 22 11 Engine mounting /](#)

22 11 100 Replacing right engine support arm (N52)

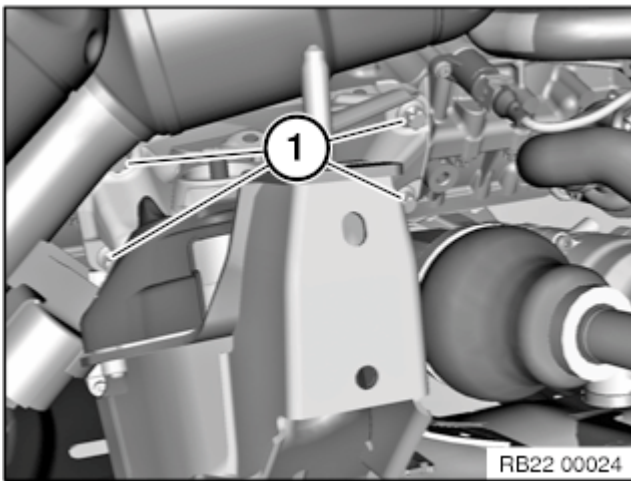
Release screws (1).

Remove engine support arm.

Tightening torque [22 11 3AZ](#).
